Subject: Clutch Release System Wear/Damage – Endurant and PACCAR Transmissions

Document Number: TAIB-0889

Date: February 1, 2021

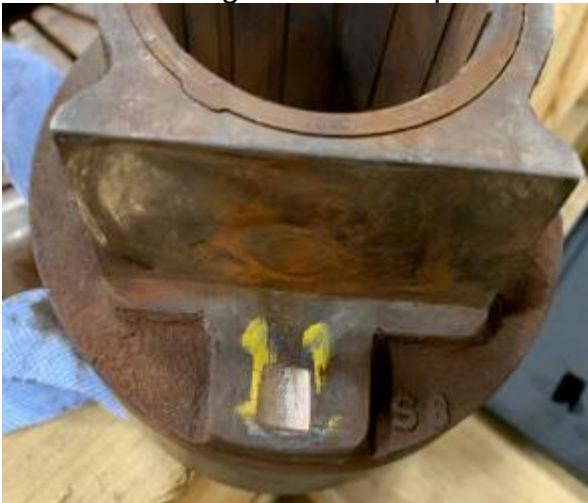
Image A:

- If no excessive wear is found, go to Step 2.
- 2. Inspect Release Bearing for wear and/or “divots” on wear pads from rollers. Document the wear measurements in the warranty claim notes. (Reference Image A.)
 - If wear is found, measure wear with a caliper.
 - If wear and/or “divot” measurement exceeds 0.5 mm in depth, replace the Release Bearing assembly and the Release Yoke. Go to Step 5.
 - If wear and/or “divot” measurement is less than 0.5 mm, go to Step 3.
 - If no wear is found, go to Step 3.

Release Bearing “Divot” Example:

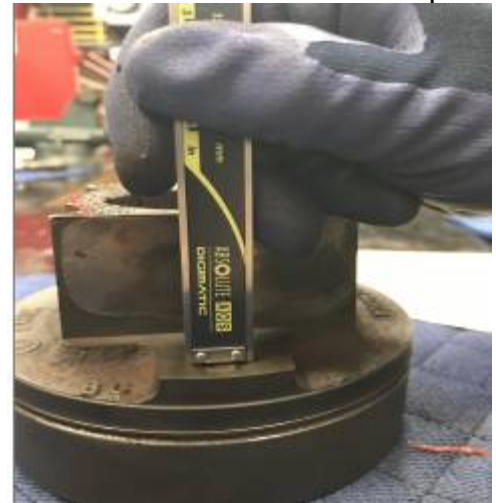
“Divot” Measurement with caliper.

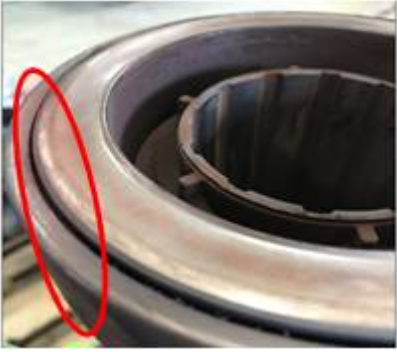
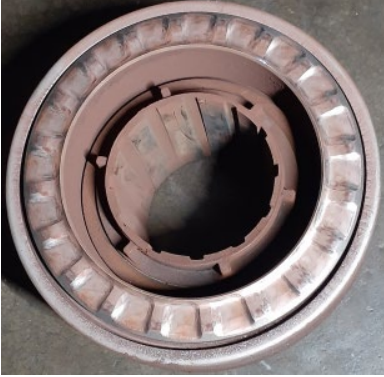
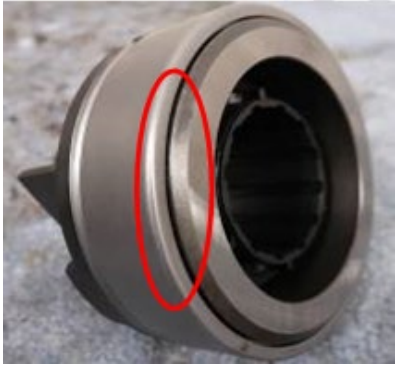
Image B: Release Bearing Assembly Face Inspection

3. Inspect Release Bearing assembly face for wear. (Reference Image B.)
 - If wear is found, measure wear with a caliper (Reference Image C). Document the wear measurements in the warranty claim notes. If the outside chamfered edge is worn off (reference Image B), then no need to measure the wear, but document “outside chamfered edge is worn off” in the warranty claim notes.
 - If wear measurement exceeds 0.75 mm or if the outside chamfered edge is worn off (reference Image B), replace the Release Bearing Assembly. Go to Step 5.
 - If wear measurement is less than 0.75 mm, go to Step 4.

Wear present		No wear present
Chamfered edge is worn off (“circumferential” wear)	“Trapezoidal” wear	New

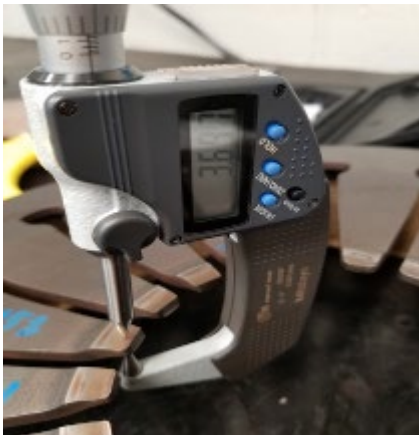
Image D: Diaphragm Spring Wear

5. Inspect the Clutch Diaphragm Spring for wear. Document the finger thickness measurements in the warranty claim notes. (Reference Image D.)
 - If wear is found, measure wear with a micrometer.
 - If the thinnest finger thickness measurement is less than 4.0 mm, replace the clutch assembly, release bearing and pilot bearing wear sleeve (clutch kit).
 - If the thinnest finger thickness measurement is greater than 4.0 mm, go to Step 6.
 - If no wear is found, go to Step 6.

Worn (Less than 4.0mm)

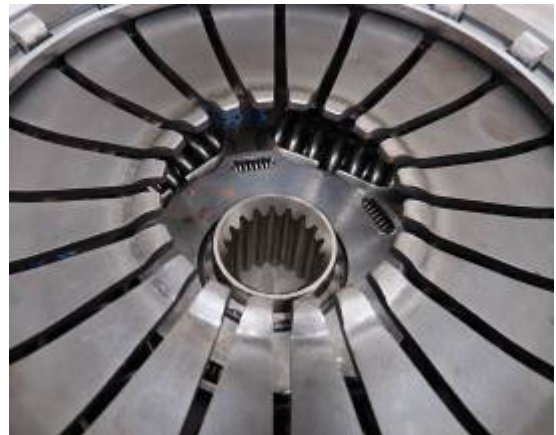
No wear (New)

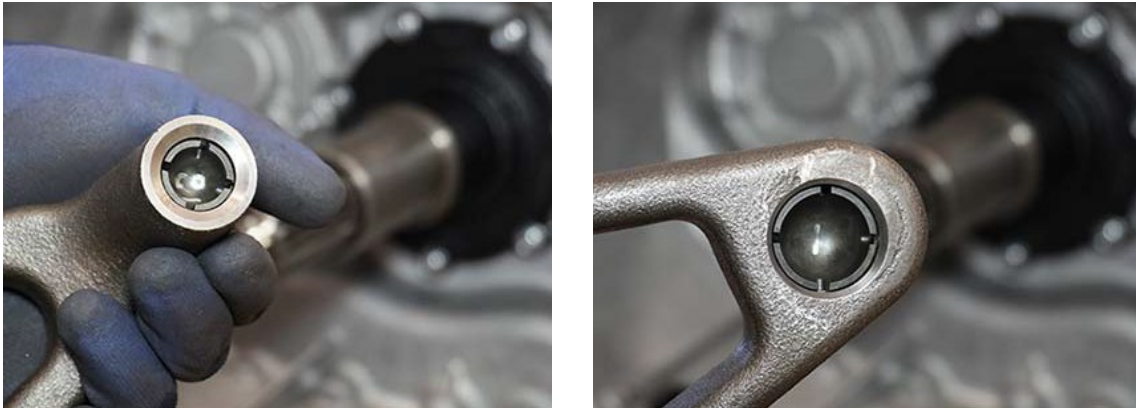
IMAGE E: Release Yoke and Plastic Sockets Inspection

6. Inspect the Release Yoke Pivot Pin, Release Yoke assembly and the plastic sockets for damage. (Reference Image E.)
 - If Release Yoke Pivot Pin and/or Release Yoke and/or plastic sockets are damaged, replace Release Yoke Assembly and Release Yoke Pivot Pin.
 - If no wear is observed, reuse Release Yoke Pivot Pin.
