Subject: Endurant HD AT and PACCAR AT Mechatronic Transmission Module (MTM)
Loose Rail Cover Cap Screws

Document Number: TAIB-0994

Date: July 19, 2021

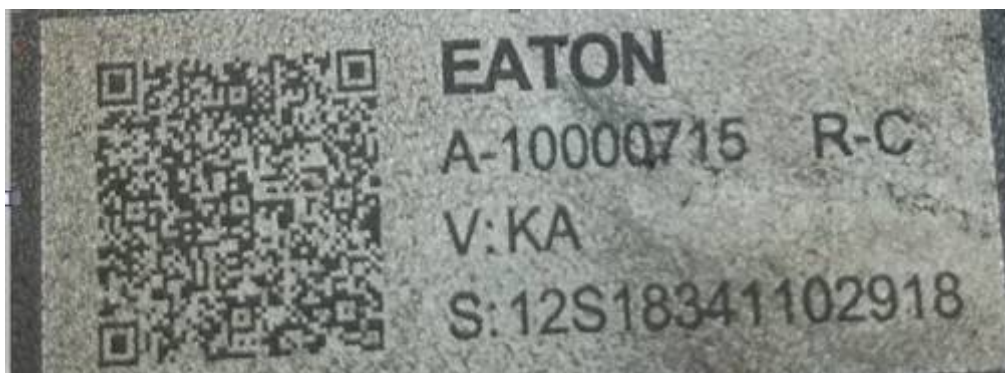
1. July 29, 2019 - 100% visual inspection to verify Loctite was applied to cap screws and rail covers were fully seated.
2. August 23, 2019 - rail cover cap screw torque was increased to 12.5 Nm.
3. September 4, 2019 - implemented refined machining process and sorting at manufacturing plants.
4. Julian Date Build Date Code etched into MTM Housing:

Vender MTM Serial Number Decoder from example above

- 12S18341102918 = 2018
- 12S18341102918 = 341st day of 2018 (December 7, 2018)

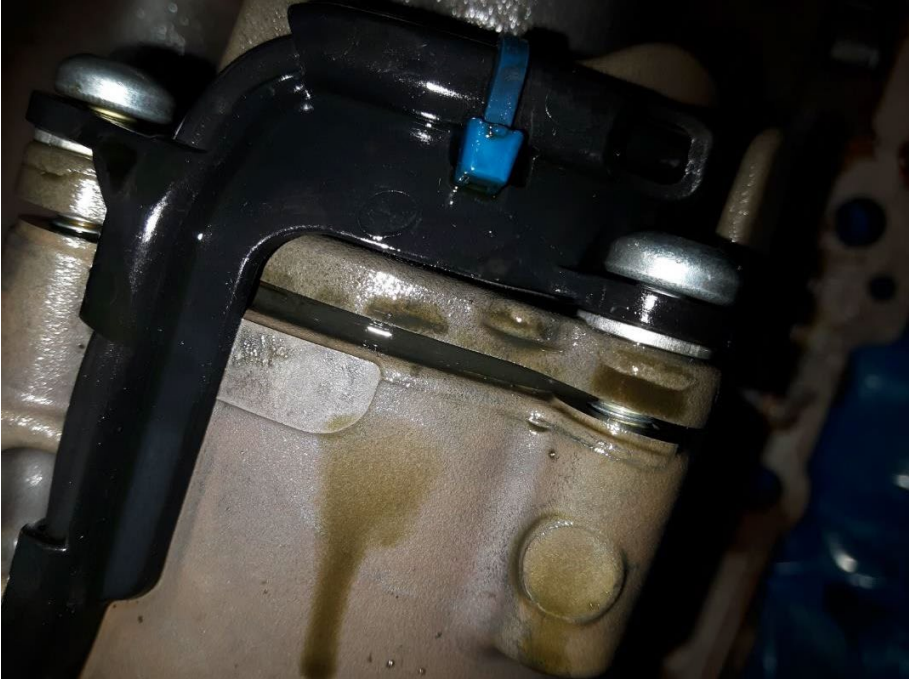
Rail B Rail Cover Loose Cap Screw Identification

MTM rail cover cap screws may come loose, leak air, and result in a Rail B or Rail C fault.

- Perform service procedure ONLY if a rail cap screw is visibly loose.
- Pictures, loose screw position, and MTM serial number must be documented in the warranty claim.
- If no loose rail cap screws are visibly verified, no further service is needed.

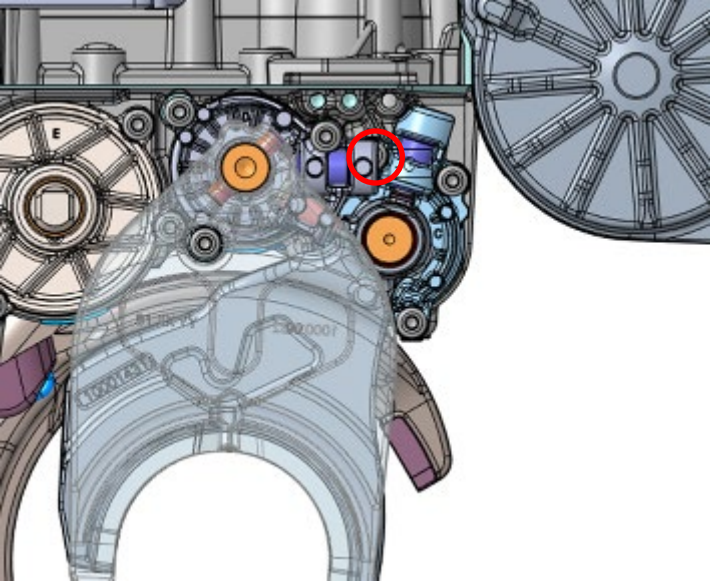
There is one cap screw on Rail C that is not accessible. Do not disassemble any other components to access this cap screw. If this cap screw is visibly loose replace the MTM.
