Subject: Main Case Oil Level Sight Glass Plug Threaded Hole Eliminated – HD Automated and Manual Models

Document Number: TAIB-1005

Date: April 03, 2023

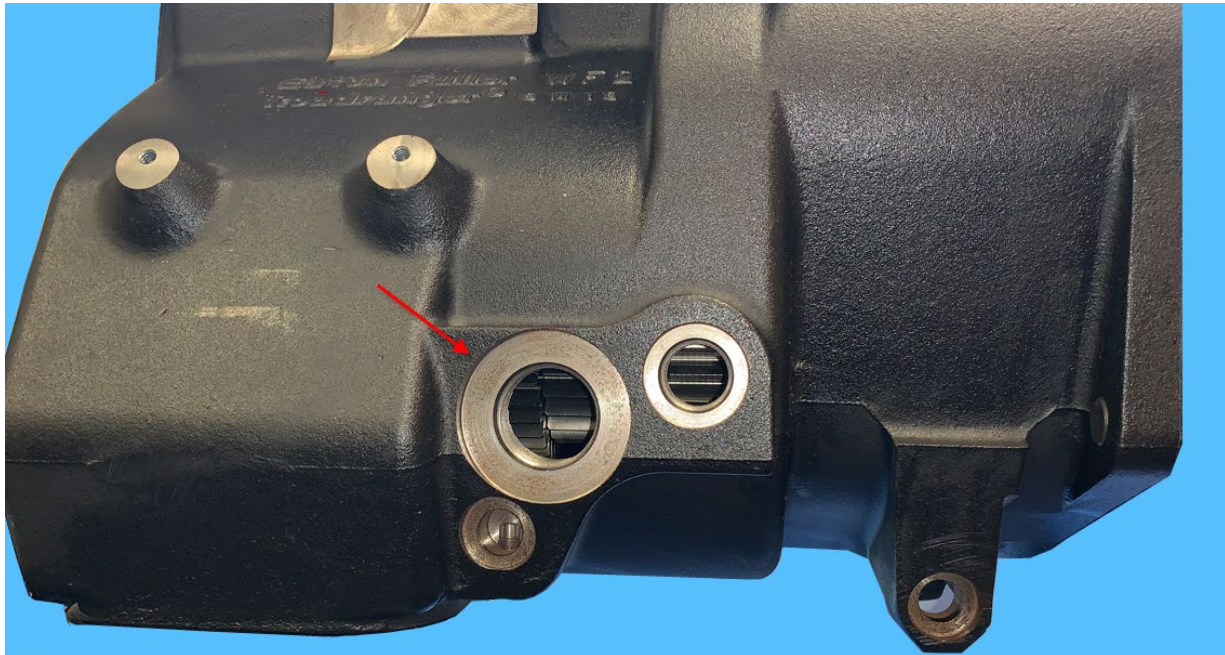
Old Design With Sight Glass Plug Threaded Hole

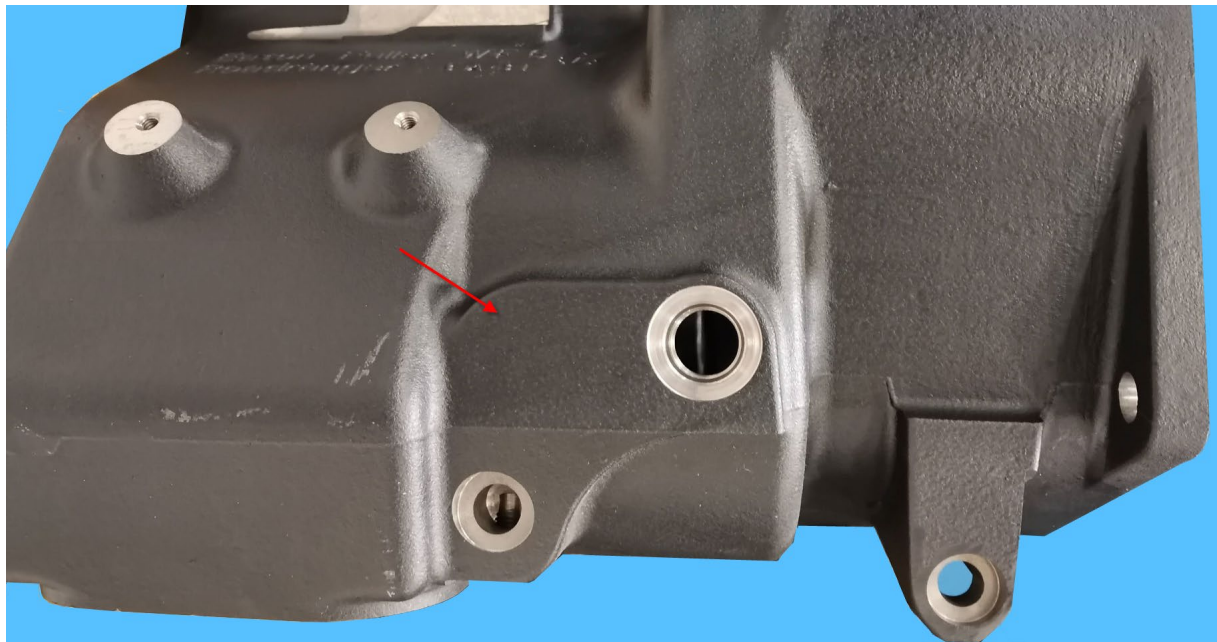
New Design Without Sight Glass Plug Threaded Hole

- No changes to main case part numbers. Customers will continue to order main case based on transmission model.
- No changes to transmission oil level fill procedures. Fill level is to bottom of the Fill Plug hole.
