Endurant Family Transmission Information Bulletin Book TRIB0900

June 2025

Service Bulletin Index1

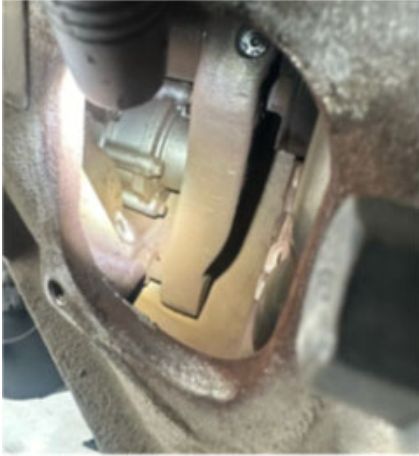
Pivot Pin not broken:

23. Through the Clutch Housing Inspection Cover, inspect Release Yoke Pivot Pin. Do not remove transmission from vehicle.
 - If Release Yoke Pivot Pin is not broken, go to Step 24.
 - If Release Yoke Pivot Pin is broken, go to TAIB0889 HD Clutch Release System Wear/Damage.

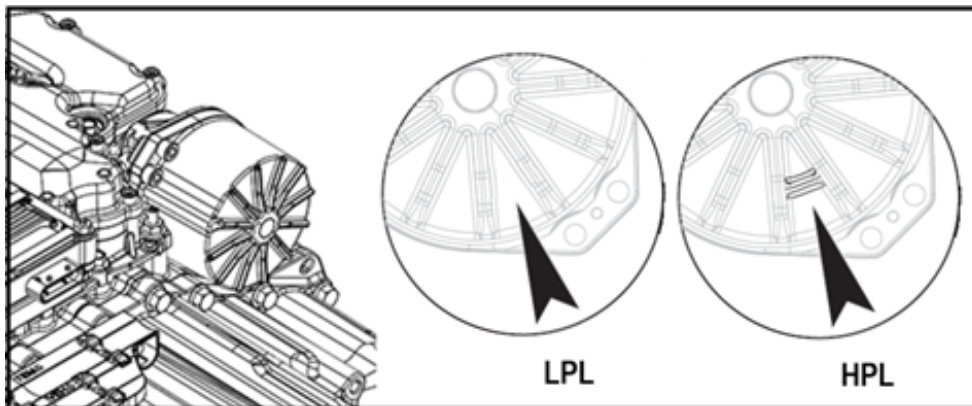
LPL - No raised casting at 5 o'clock position

HPL - Raised casting at 5 o'clock position

- If equipped with an LPL LCA, replace the LCA. Go to Step 26.
 - Refer to Endurant HD Service Manual TRSM0950, LCA service procedure.
- If equipped with an HPL LCA, go to Step 30.

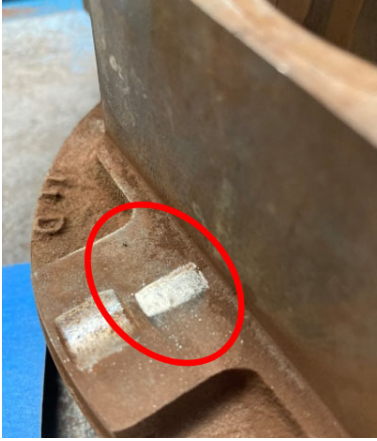
- If release bearing casting has come into contact with release yoke casting, replace the release bearing, release yoke and the release yoke pivot pin. Go to Step 7.

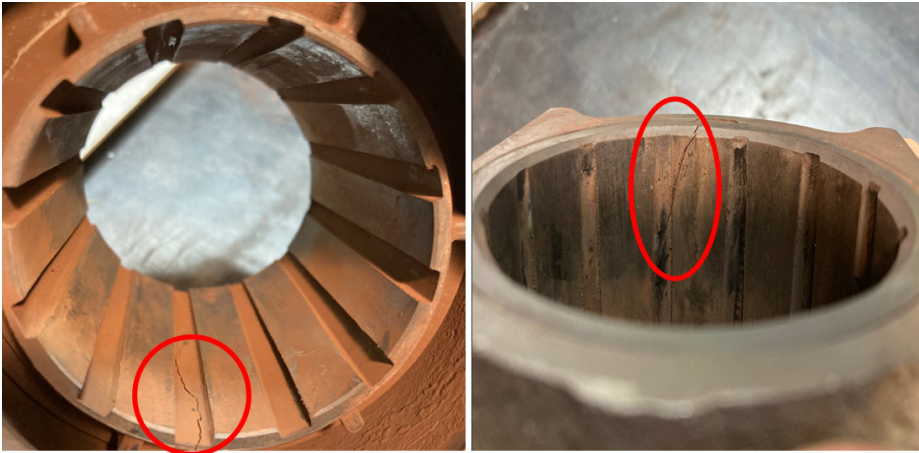
- If the release bearing inner sleeve is cracked or broken, replace the release bearing. Go to Step 6.

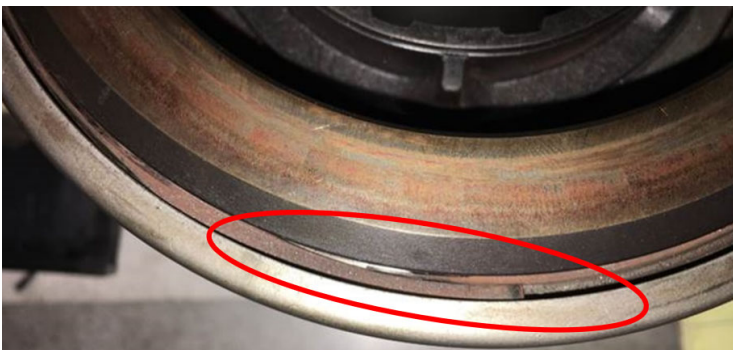
- If the inner wave spring is protruding from the face of the bearing, replace the release bearing. Go to Step 6.

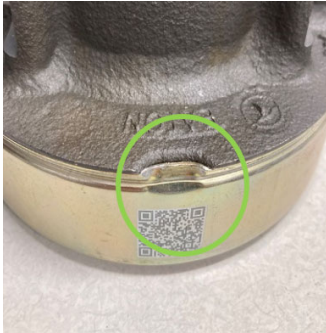
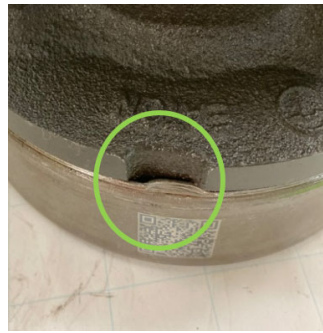
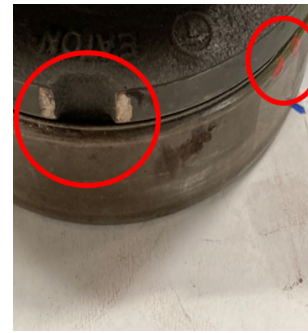
*New**Partially Rotated (Reuse)**Rotated (Replace)*

- If the release bearing outer baffle has rotated fully outside of the original staked position, replace the release bearing assembly. Go to Step 6.

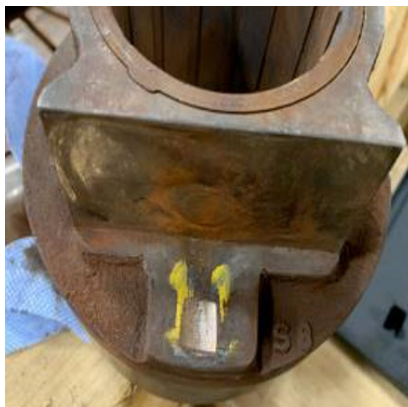
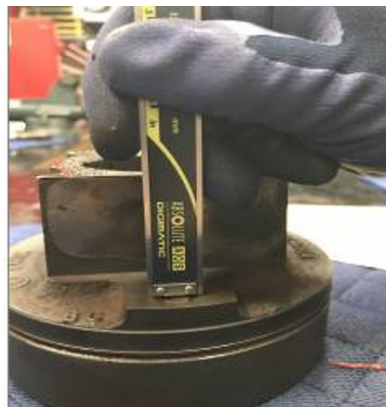
3. Inspect release bearing assembly for wear and/or “divots” on wear pads from rollers. Document the wear measurements in the warranty claim notes.

- If wear is found, measure wear with a caliper.

- If wear and/or “divot” measurement exceeds 0.5 mm in depth, replace the Release Bearing assembly. Go to Step 6.
- If wear and/or “divot” measurement is less than 0.5 mm, go to Step 4.

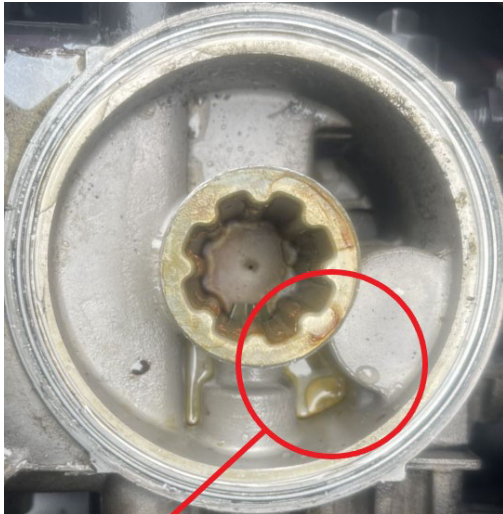
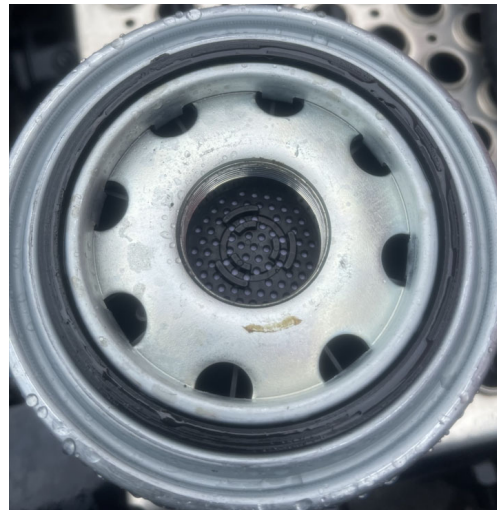
No Contamination Indicated:

Note: Moisture (Water) droplets found on the cartridge base is normal.

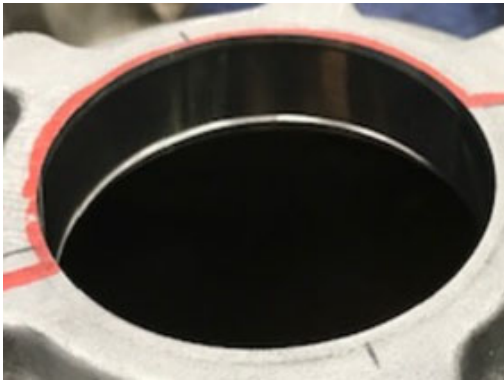
Countershaft Bearing Bore Wear (Clutch Housing / Main Housing):

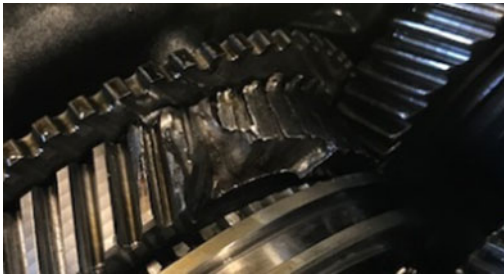
Broken main drive gear teeth:

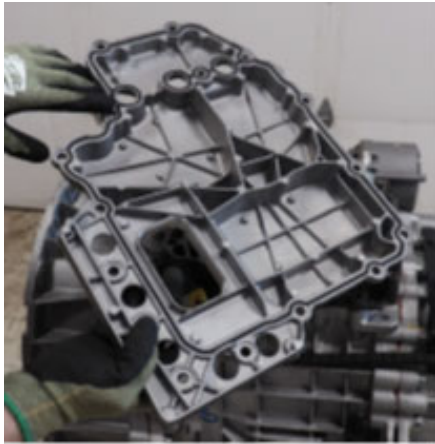
3. Inspect MTM Cover O-ring, press in place seal, for damage.
 - a. If no damage, go to Step 4.
 - b. If damaged, replace MTM or O-ring if available.

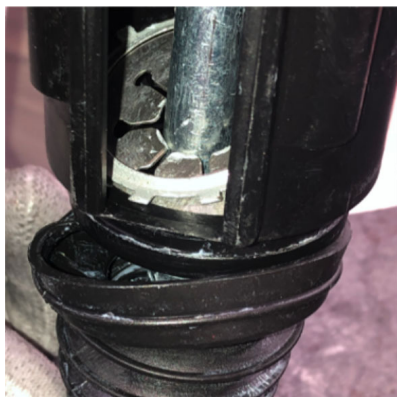
Note: This issue does not impact the transmission during normal operation and is only observed during an LCA service event.
