Subject: MTM Solenoid Fault Codes and Vehicle Air System Contamination – Endurant HD, XD and PACCAR TX-12, TX-18

Document Number: TAIB-1006

Date: April 6, 2023

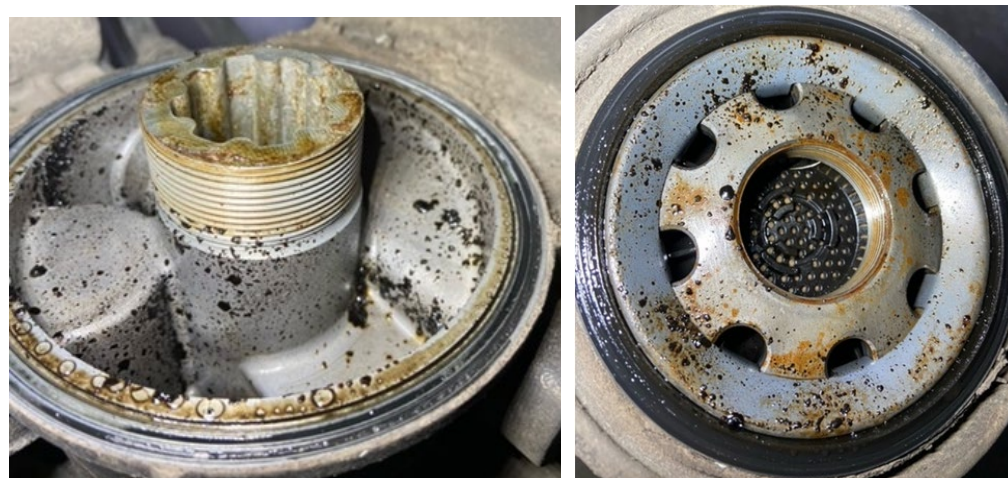
Contamination indicated:

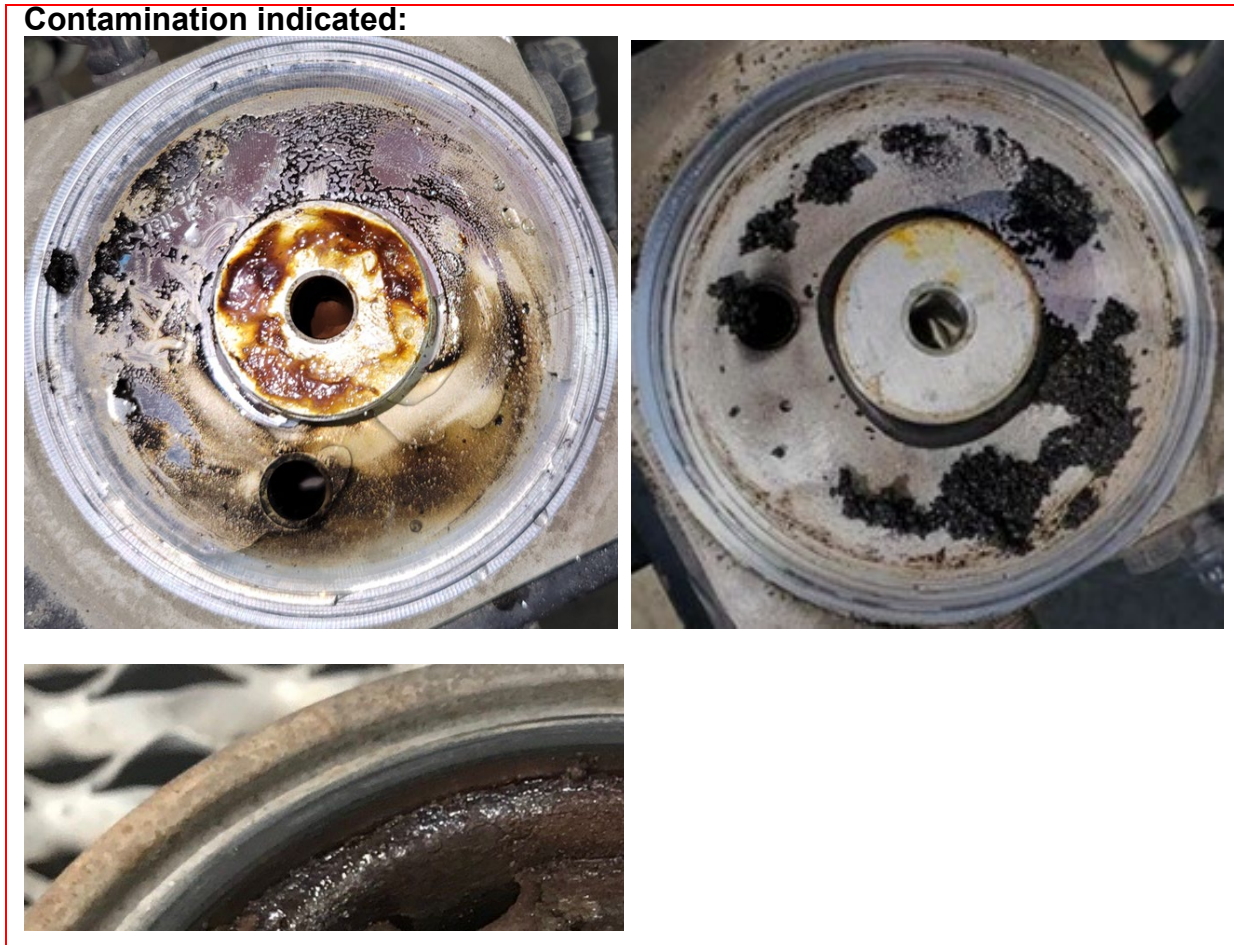
**Air Dryer Cartridge (continued):
Contamination indicated:**

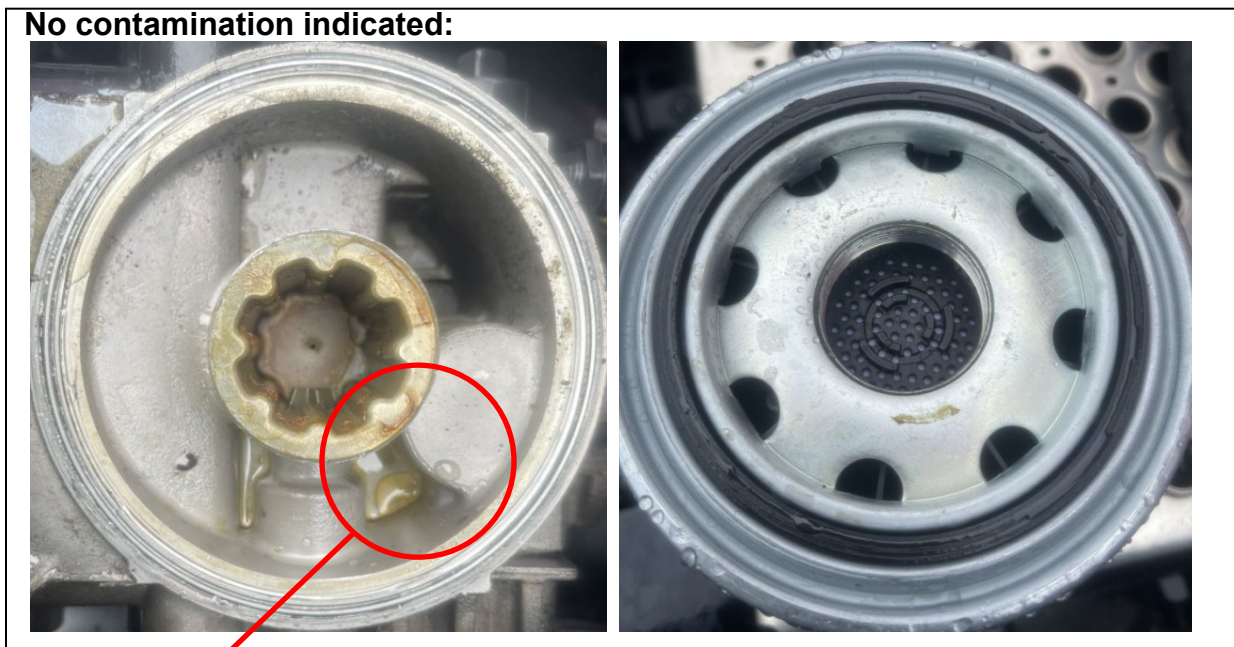
No contamination indicated:

Note: Moisture (Water) droplets found on the cartridge base is normal.

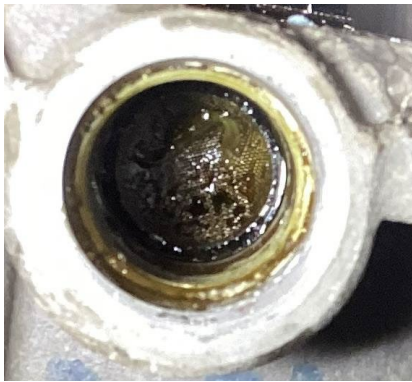
Amber Contamination and Moisture

***NOTICE:** Eaton Cummins Automated Transmission Technologies recommends inspection and repair of the vehicle air system to correct the source of contamination. Refer to OEM and/or vehicle air system manufacturer maintenance guidelines to ensure proper air system operation, i.e., drain water from air tanks, replace air system filters and cartridges. Refer to [Vehicle Maintenance Recommendations](#).

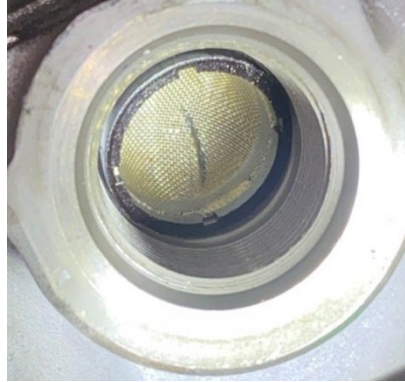
Amber Contamination

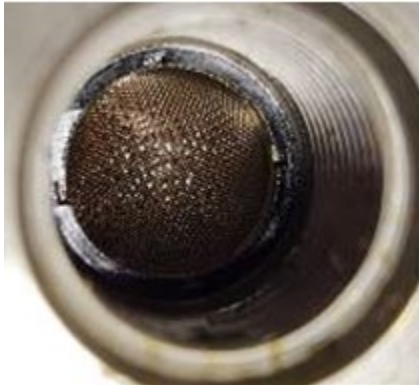
Moisture / Rust

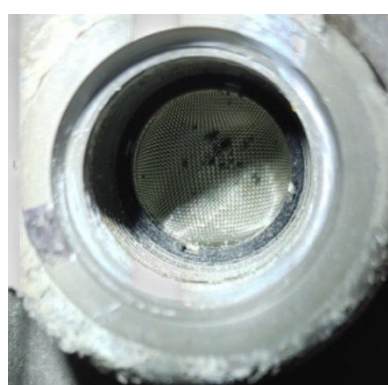
Carbon Particles

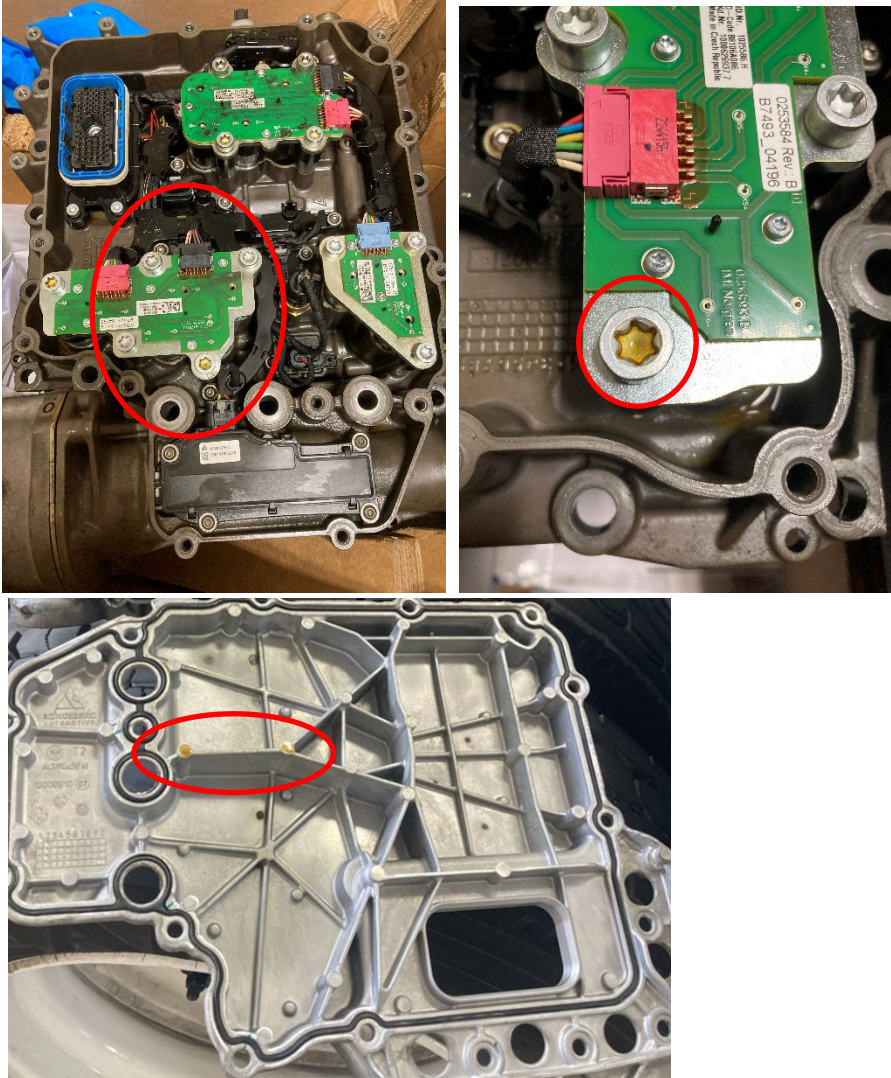
MTM - Non-warrantable:

Amber only substance contamination:

***NOTICE:** Eaton Cummins Automated Transmission Technologies recommends inspection and repair of the vehicle air system to correct the source of contamination. Refer to OEM and/or vehicle air system manufacturer maintenance guidelines to ensure proper air system operation, i.e., drain water from air tanks, replace air system filters and cartridges. Refer to [Vehicle Maintenance Recommendations](#).

- Recommend MTM replacement and Inertia Brake inspection.
- Refer to OEM and repair/maintain vehicle air system.
- Refer to [Vehicle Maintenance Recommendations](#).

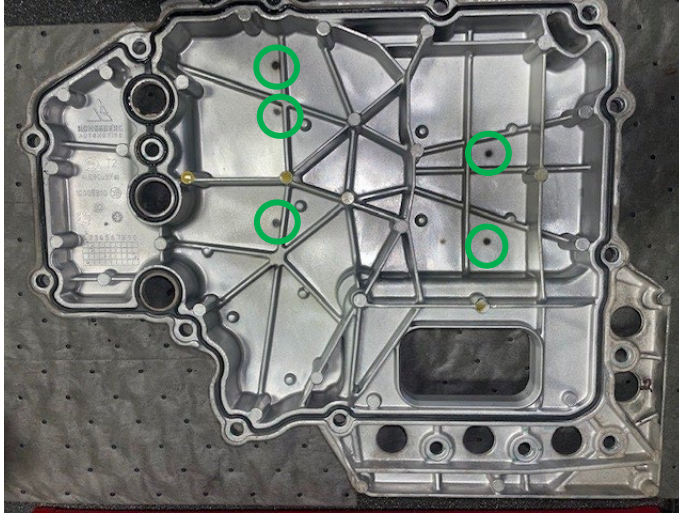
MTM – Normal

Trace amounts of transmission oil exhausted from the valve is considered normal.

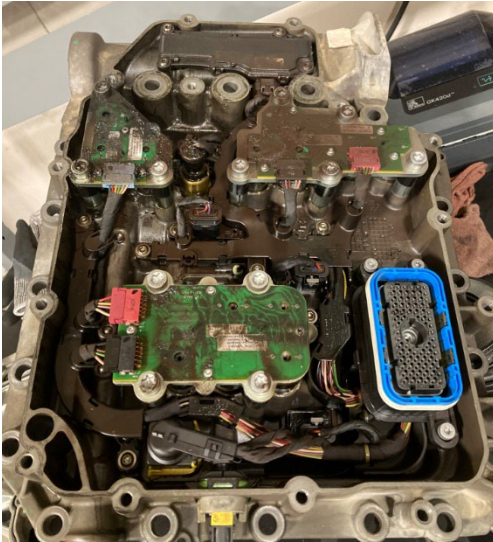
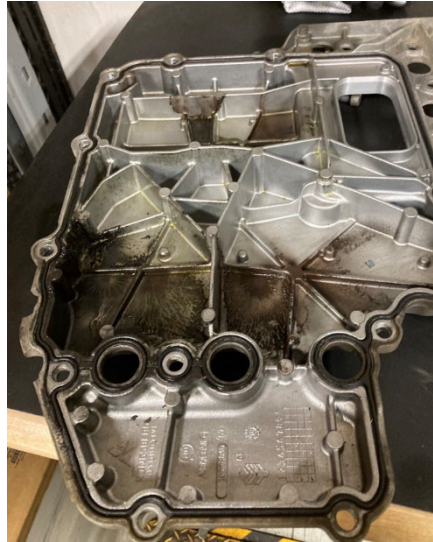
MTM - Warrantable:

Black substance contamination:

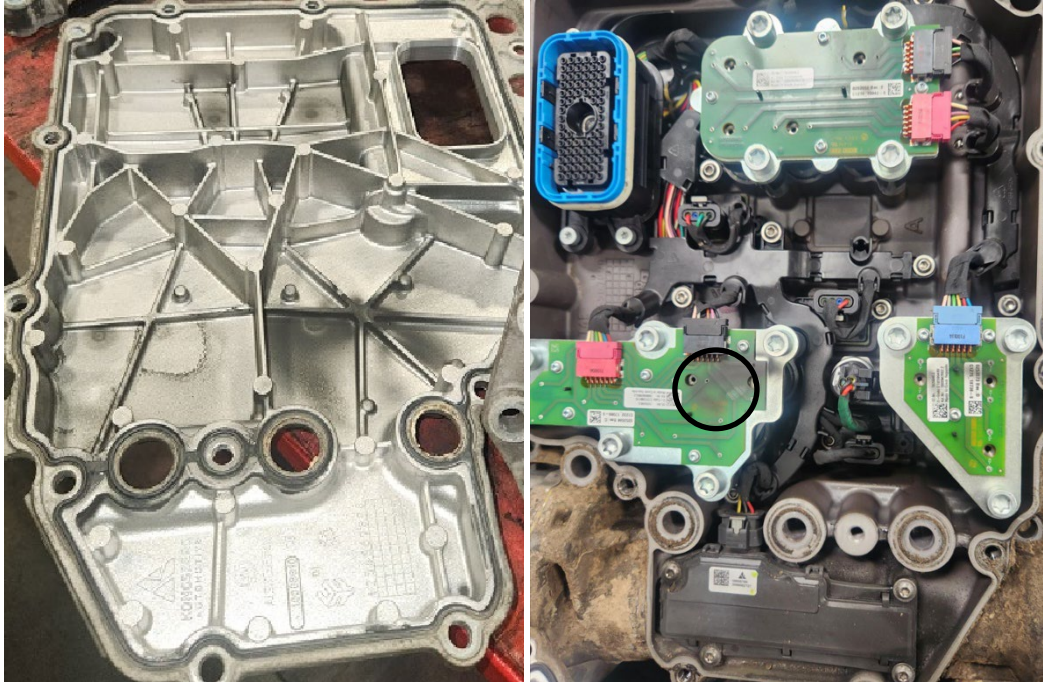
MTM - Warrantable

Black substance contamination:

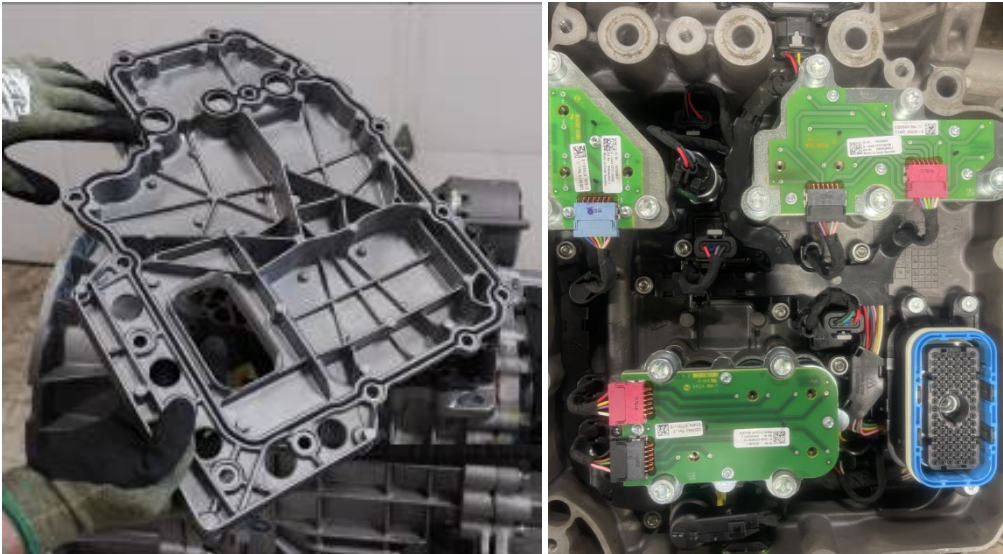
MTM - Warrantable

No Contamination:

18. Replace MTM only (Warrantable Repair).
