Subject: Fault Code 27 FMI 7 and/or 64 FMI 7 Set Active After ECA Installation

Document Number: TAIB-0996

Date: January 31, 2022

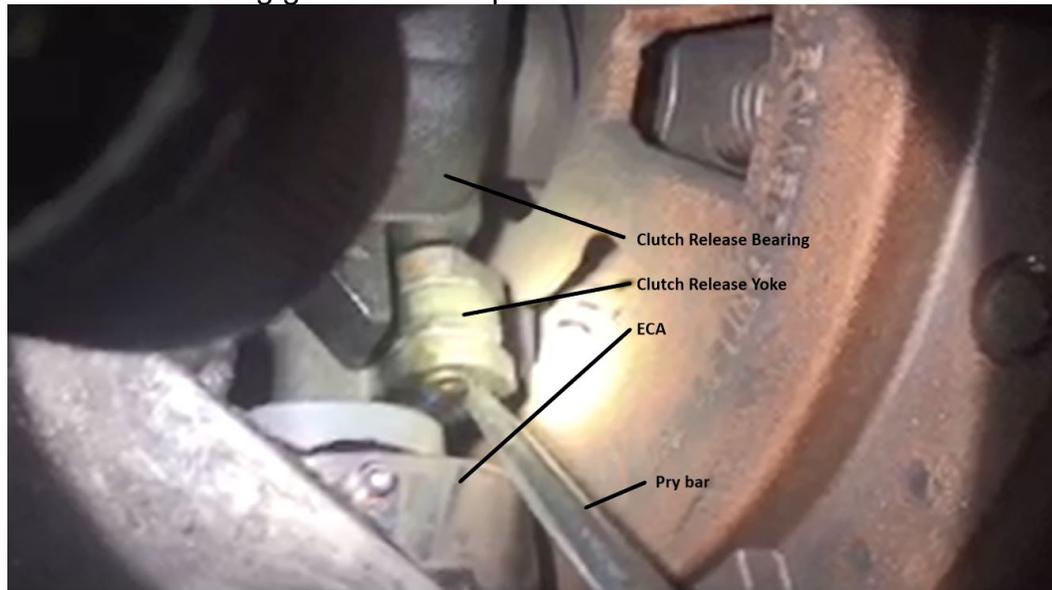
1. Set parking brake and chock wheels.
2. Key off.
3. Loosen clutch housing inspection cover retaining bolt.
4. Using a suitable pry bar, move Clutch Release Yoke toward clutch release bearing, up and down, review video in link: [Spline Shaft Check for Binding](#)
 - a. If the Clutch Release Yoke does not move freely up and down, go to **Step 5**.

- b. If the Clutch Release Yoke moves freely up and down, as indicated in video, and Fault Code 27 FMI 7 and/or 64/7 is Active, go to troubleshooting guide and complete Fault Code Isolation Procedure.
