Subject: Proactive Precision Needle Bearing 4307821 Replacement Program

Document Number: TAIB-0887

Date: November 4, 2020

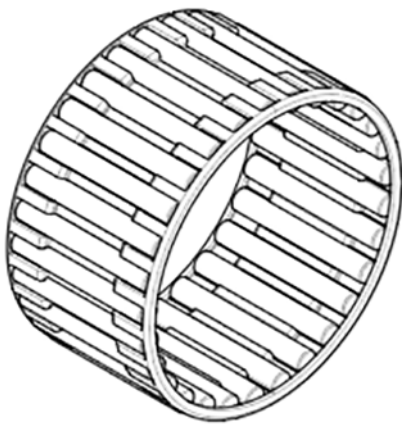
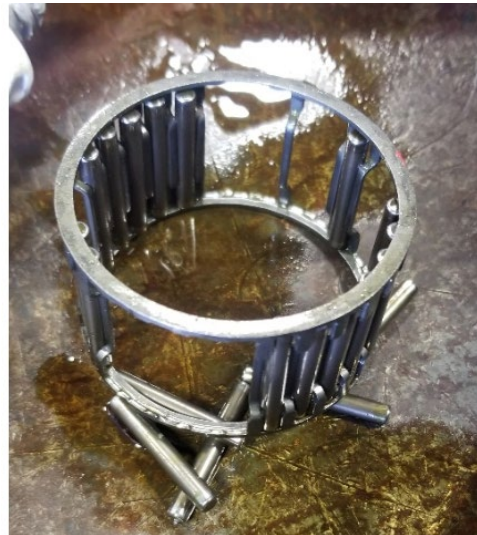
4th & 6th Gear Needle Bearing Failure – P/N 4307821

Proactively replace needle bearings and small related parts (K-4507) in chassis; drain and replace transmission oil. Refer to the service procedure video at: <https://bcove.video/2GcE3gx>.

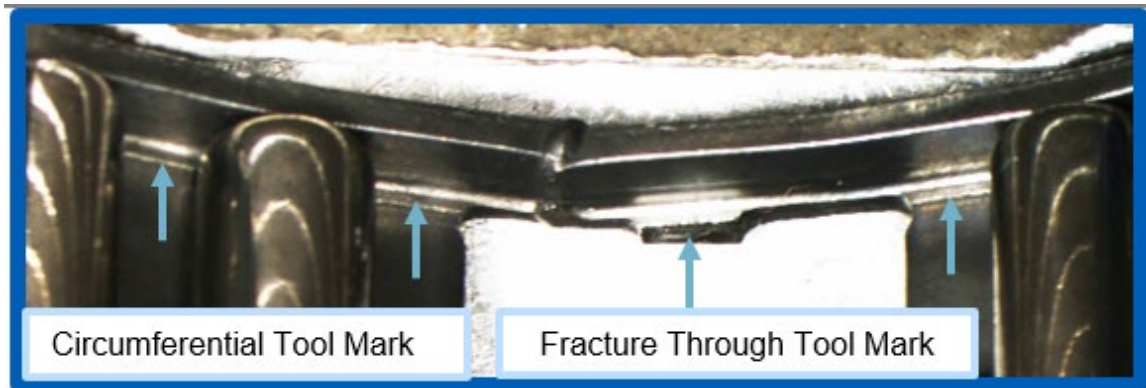
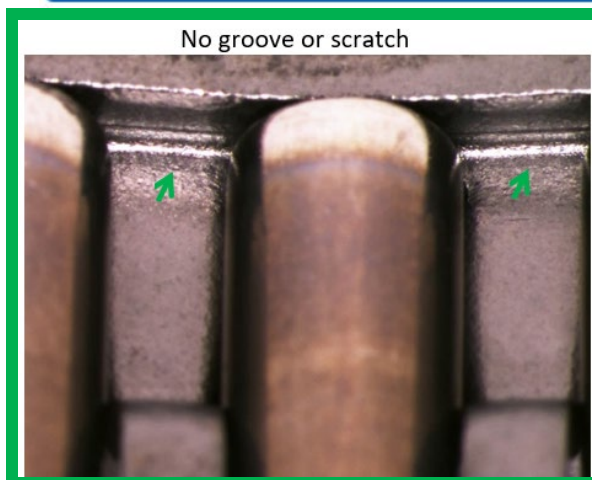
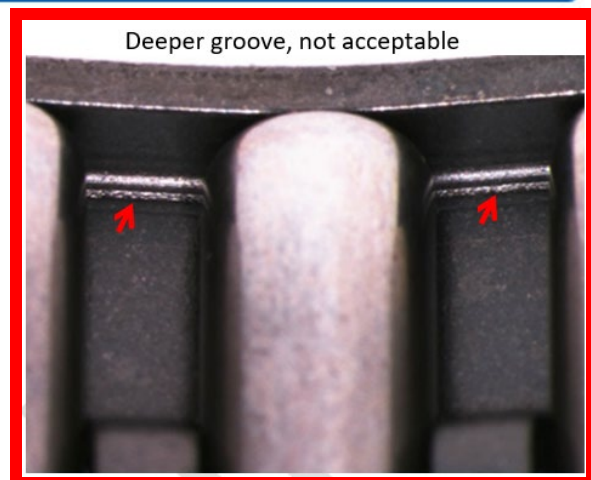
Root Cause: Tool marks on bearing cage bar

Containment/Corrective Action: New bearings that met quality standards were put in place at remanufacturers and Eaton Cummins Automated Transmission Technologies stock at ELC September 18, 2020.
