Subject: Fault Code 19, 64 and 67 PACCAR Vehicles – UltraShift PLUS and Fuller Advantage Automated Transmissions

Document Number: TAIB-0883

Date: August 10, 2020

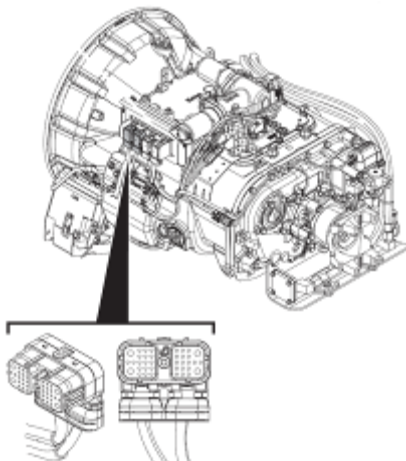
8. Disconnect 38-Way Vehicle Interface Harness Connector at the TECU.

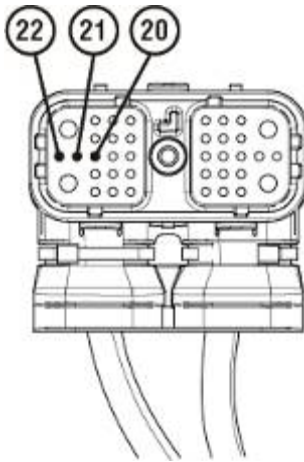
9. Inspect 38-Way Connector for populated pins 20, 21 and 22.

10. Determine troubleshooting/repair direction.
 - If pins 20, 21 and 22 are populated, perform the instructions outlined below to remove the MEIR circuit from the TECU 38-Way Connector.
 - If pins 20, 21 and 22 are not populated, reconnect all connections and refer to either the UltraShift *PLUS* Troubleshooting Guide (TRTS0940) or Fuller Advantage/Smart Advantage Troubleshooting Guide (TRTS0980) to troubleshoot Fault Code(s) per Fault Code Isolation Procedure Index.
