**Subject:** Fault Code 73 FMI 7 After Recent Input Shaft Replacement – USP/FAA

**Document Number:** TAIB-0997

**Date:** February 21, 2022

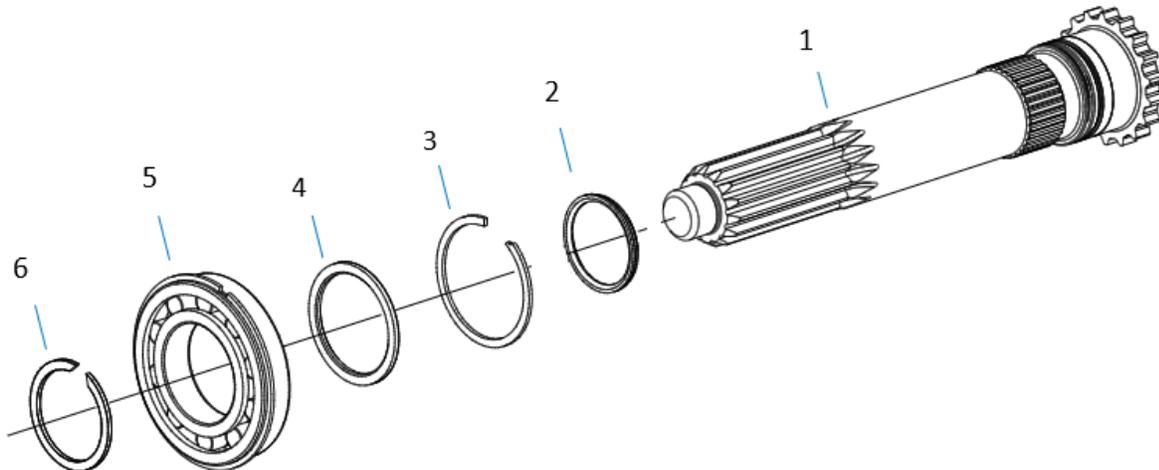
During the Input Shaft Installation procedure, the Input Shaft Spacer (Item 4) may have been installed before (or underneath) the snap ring (Item 3). This forces the Main Drive Gear rearward not allowing full engagement of the front sliding clutch into the Main Drive Gear. When the vehicle is driven the XY Shifter Actuator position sensor indicates minimum gear engagement was **not** achieved and the TECU sets Fault Code 73 FMI 7.

Image below indicates order of installation for Input Shaft Spacer (Item 4):

If the Input Shaft was recently installed or replaced and Fault Code 73 FMI 7 sets Active during a gear shift of the front sliding clutch into the Main Drive Gear, perform the Field Strategy outlined below and check for proper installation of the Input Shaft Spacer (Item 4).

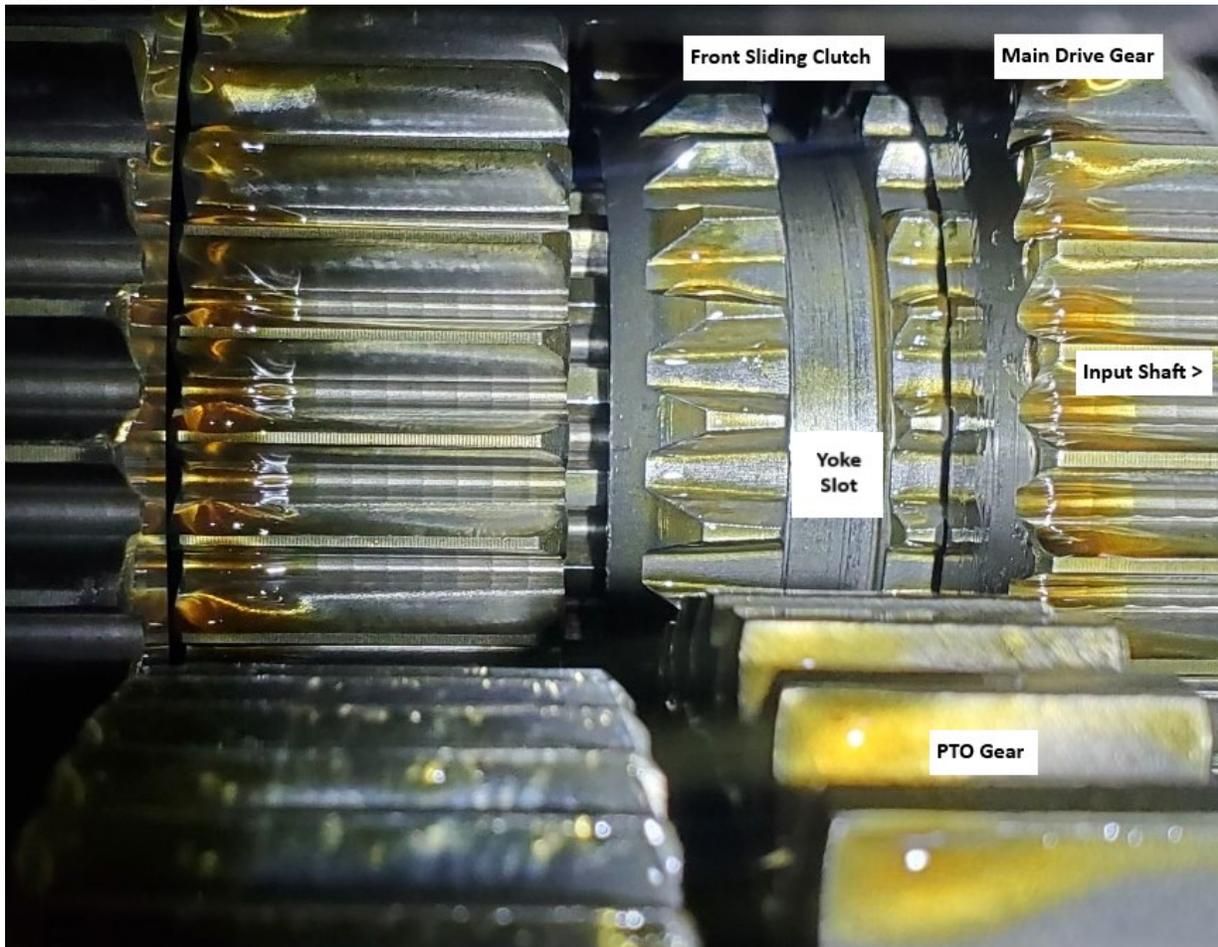
**Note:** Image below is through PTO opening. Sliding clutch is **not** fully engaged into Main Drive Gear:

7. Inspect position of front sliding clutch yoke slot in relationship to Main Drive Gear.
  - a. If sliding clutch yoke slot is **not** flush with Main Drive Gear sidewall, suspect incorrect installation of Input Shaft Spacer. Go to appropriate service manual and complete Input Shaft Removal and Installation service procedure.
  - b. If sliding clutch yoke slot is flush with Main Drive Gear, go to appropriate troubleshooting guide and complete Fault Code Isolation Procedure.
