MTM Transmission Air Supply Pressure Sensor Repair Procedure

Date: September 6, 2023

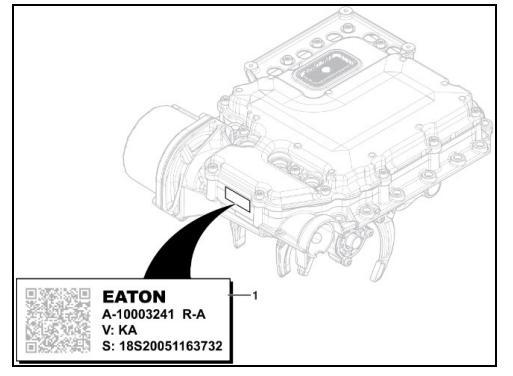
MTM Type can also be identified by the MTM part number located on MTM part label (1):

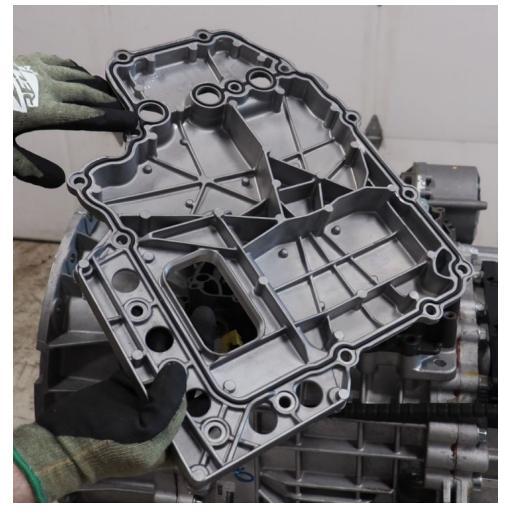
- **3.** Inspect MTM Cover O-ring, press in place seal, for damage.
 - a. If **no** damage, go to **Step 4**.
 - b. If damaged, replace MTM or O-ring if available.

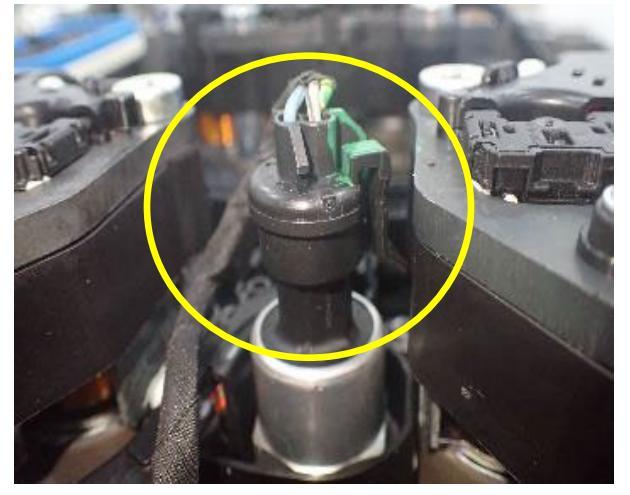
- **6.** Inspect 3-Way TASPS Connector wires, confirm wires are not damaged and terminals are properly seated/locked into connector.
 - a. If wires are damaged and/or terminals not properly seated/locked into connector, record findings and **replace MTM**.
 - b. If **no** wire damage and terminals are properly seated/locked in connector, go to **Step 7**.
- **7.** Carefully disconnect the 3-Way TASPS Connector by moving the retaining clip aside and gently pulling on the connector.

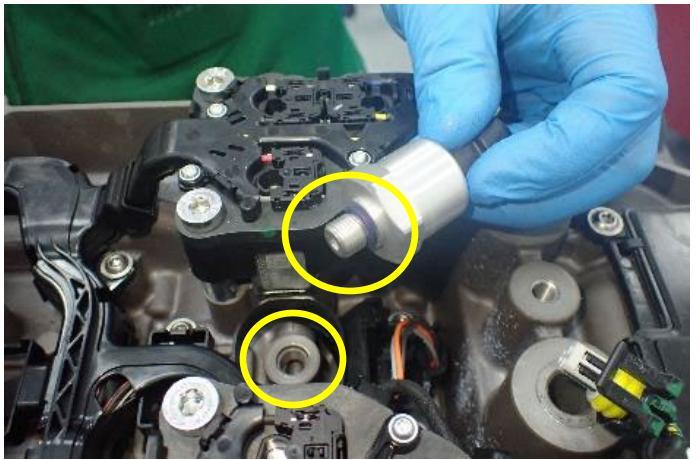
9. Inspect removed TASPS and MTM side of TASPS threaded opening, ensure O-ring came out with sensor and opening is free of debris.

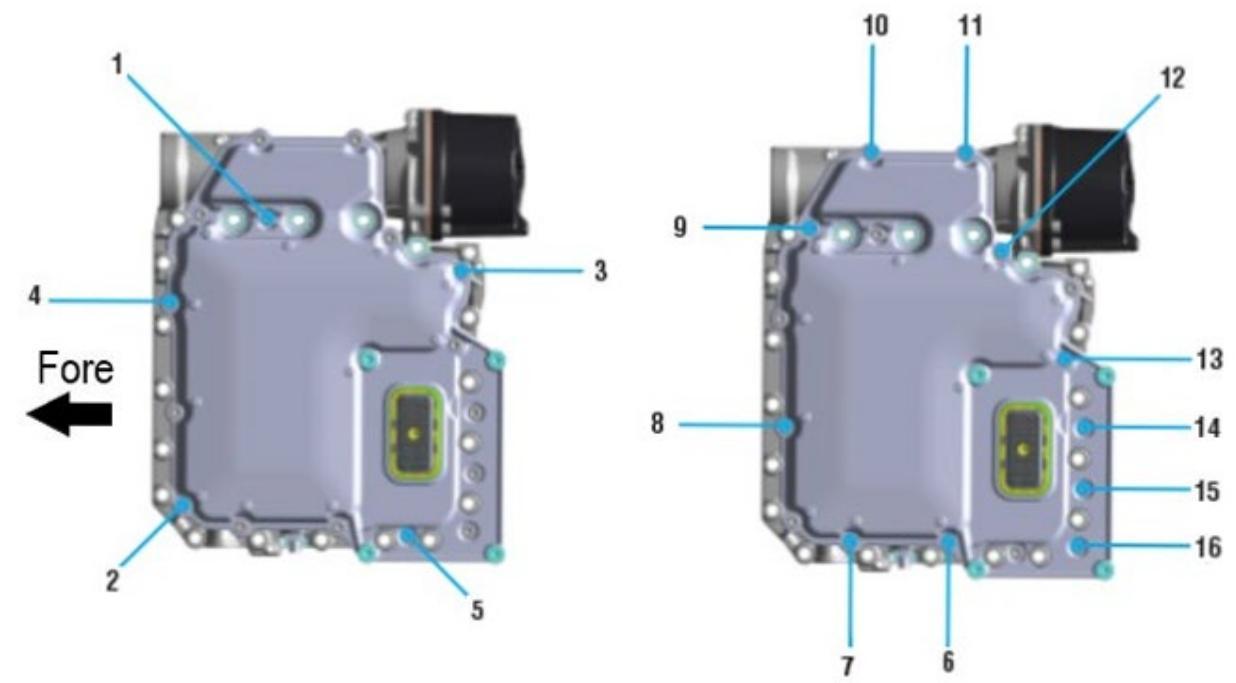
CAUTION: Follow the MTM Cover cap screw torque specification and sequence as shown. Failure to follow torque specification and sequence may cause in an improper seal between the cover and housing resulting in water ingestion.

- **4.** Install 16 MTM Cover to MTM Housing T45 cap screws.
- **5.** Torque MTM Cover cap screws 1 through 5 and 6 through 16 to 23–27 Nm (17-19 ftlb) as shown in the torque sequence below.
