Warranty Repair Guidelines TCWY1250 EN-US

May 2020

Mechanical Transmission

(Pre-Authorization Warranty Repairs)

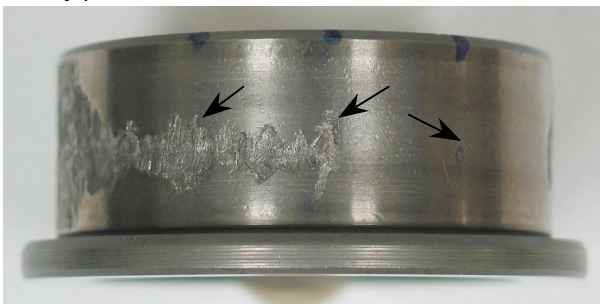
Partially pitted

Failed bearing is partially pitted - contamination is not severe - minor failure.

Repair Guideline - Minor:

- Replace 4 C/S bearings only, gaskets and oil.
- Re-use input bearing, inspect/re-use auxiliary drive gear bearing.
- Auxiliary section to be flushed/inspected only not disassembled.

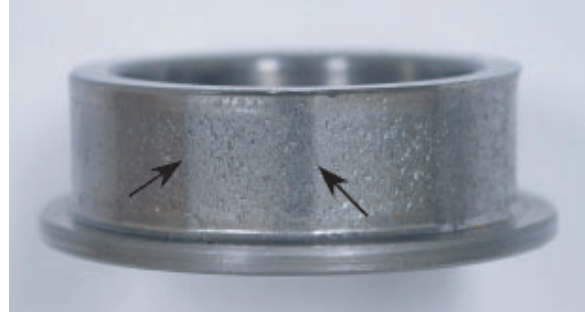
Severally pitted, race worn down

If race has the entire surface damaged, contamination is severe - major failure.

Repair Guideline - Major:

- Replace 4 C/S bearings.
- Replace input shaft bearing.
- Clean/inspect replace auxiliary. drive gear bearing if pitting is found on the races.
- Auxiliary section to be flushed/inspected only not disassembled*.
- Mainshaft should be disassembled and damaged parts replaced.
- The input bushing will generally be damaged and can be replaced if bore in the input shaft is not damaged.

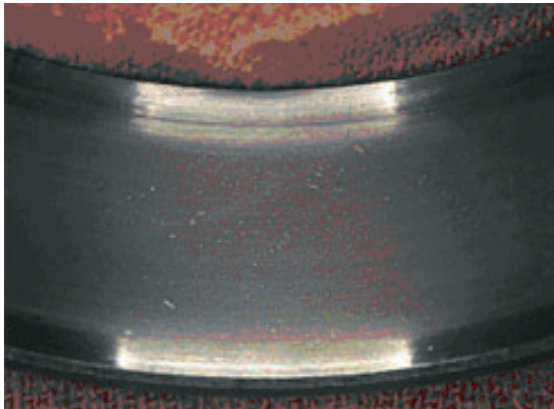
Re-use

Dull polish, light debris dents, no pitting.

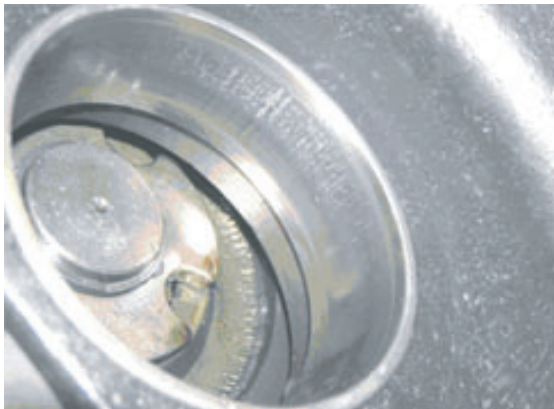
Replace

Spalling on races, pitting on rollers

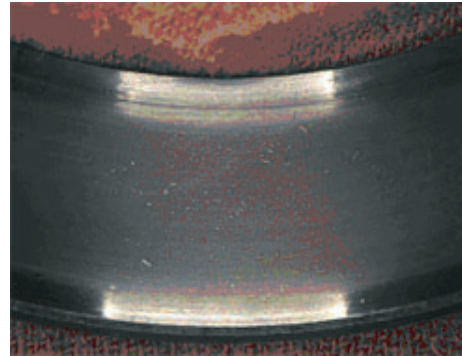
Re-use

Dull polish, light debris dents, no pitting.

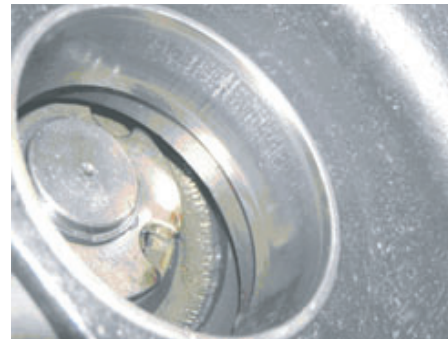
Replace

Spalling on races, pitting on rollers

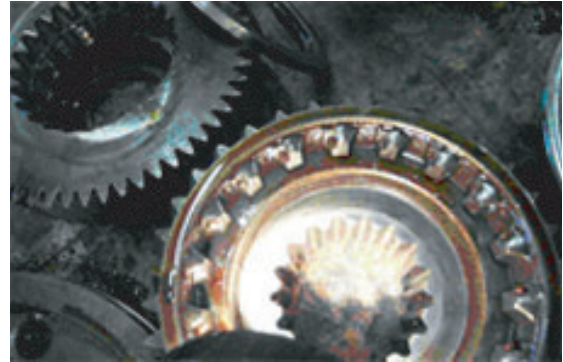
Figure 1: Fretting damage on the auxiliary drive gear clutching teeth.

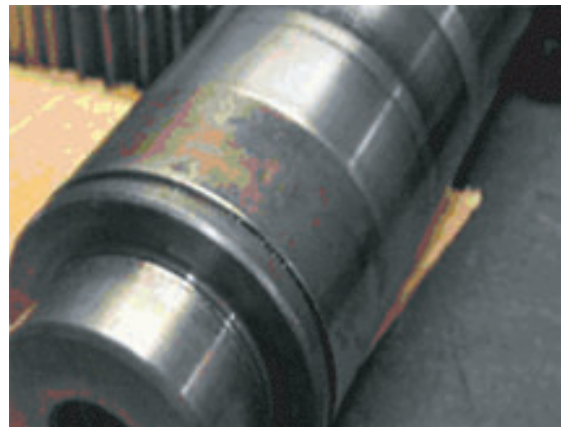
Figure 2: Fretting damage (wear) on countershaft from a loose gear.

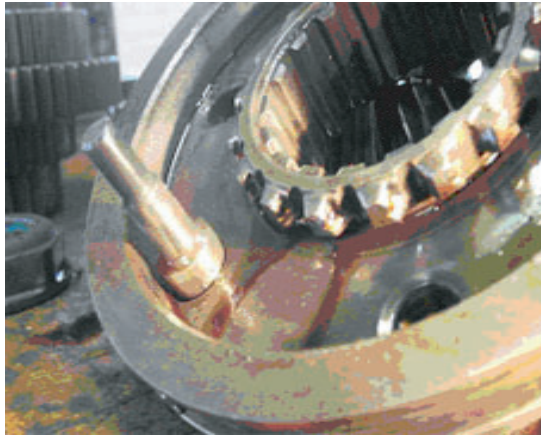
Figure 3: Fretting damage on range clutch on high side.

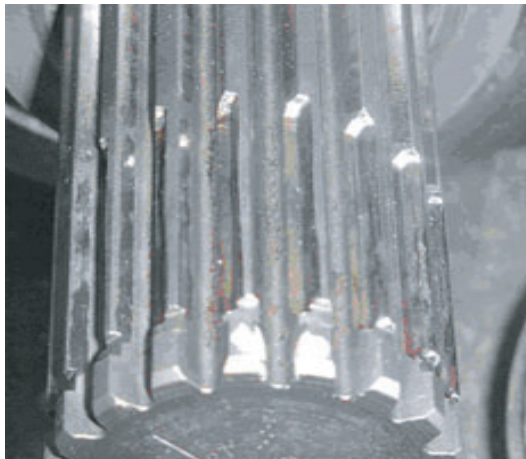
Check the rear end of the front box mainshaft splines (see figure 4).

Figure 4: Fretting damage to end of front box mainshaft.

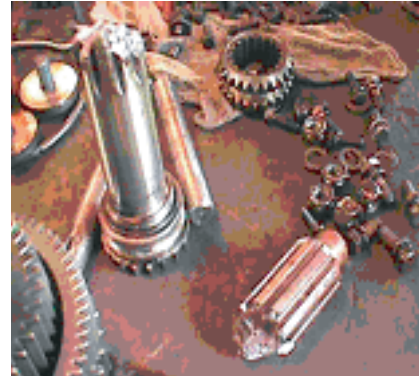
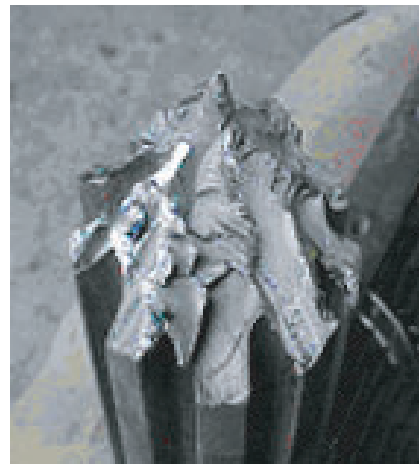
Pictures of non-warrantable failures:

Non-warrantable failure; claim can be sent in through normal warranty for review if requested.

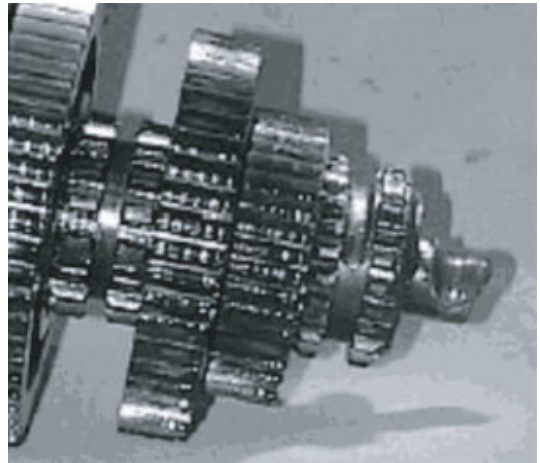
Figure 1: Notice the mainshaft pilot wear bias one side due to centrifugal force.

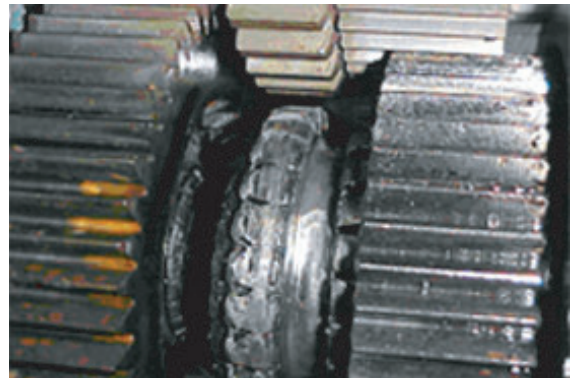
Figure 2: FRO unit overdrive clutch skewed to one side and burned.

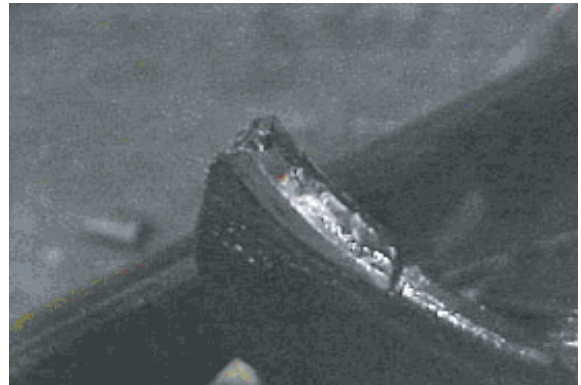
Figure 3: Shift yoke burned and broken off from M/S being skewed.

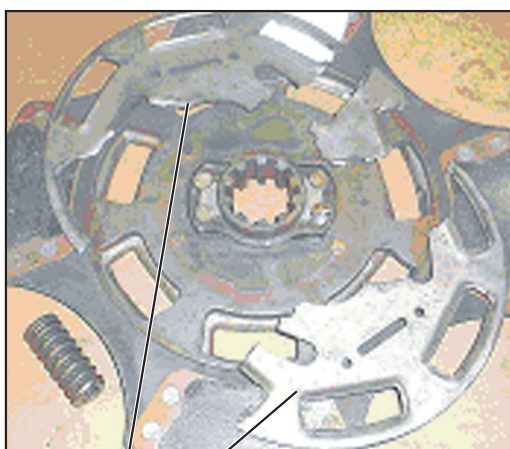
Broken Spring Cover

Broken disc damper spring(s).

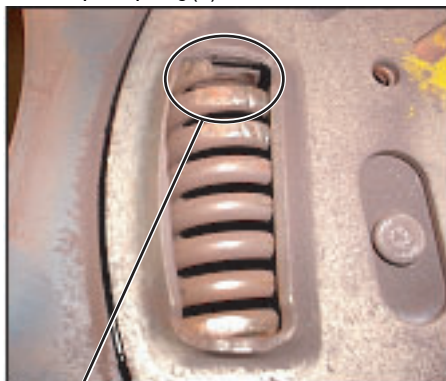
Broken Damper Spring

Broken disc damper spring(s).

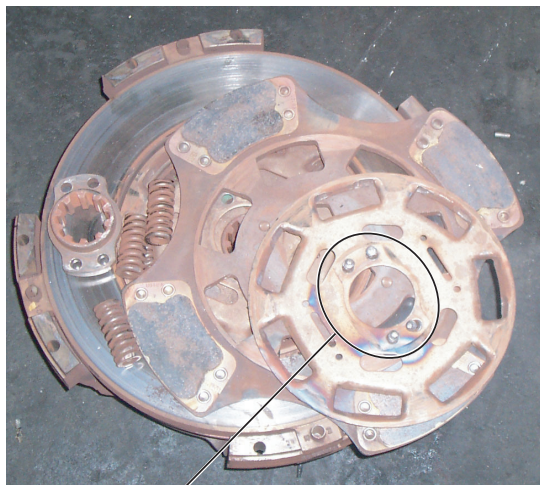
Broken Hub Rivets

Broken disc damper hub rivets.
