Subject: Endurant HD AT and PACCAR AT Mechatronic Transmission Module (MTM)
Loose Rail Cover Cap Screws

Document Number: TAIB-0994

Date: July 19, 2021

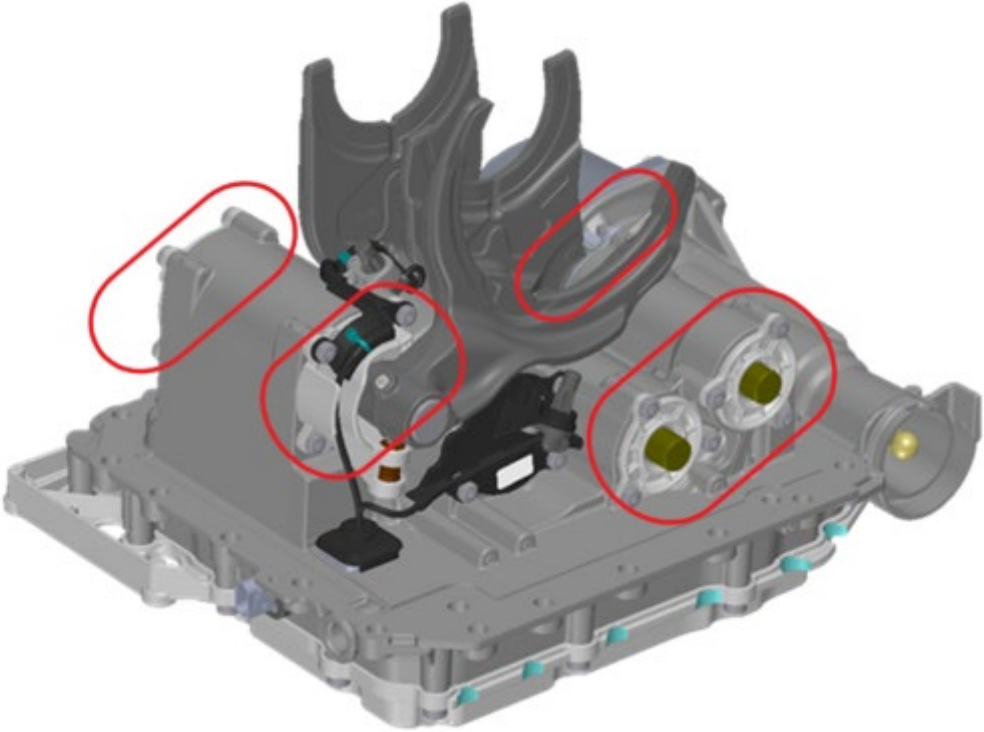
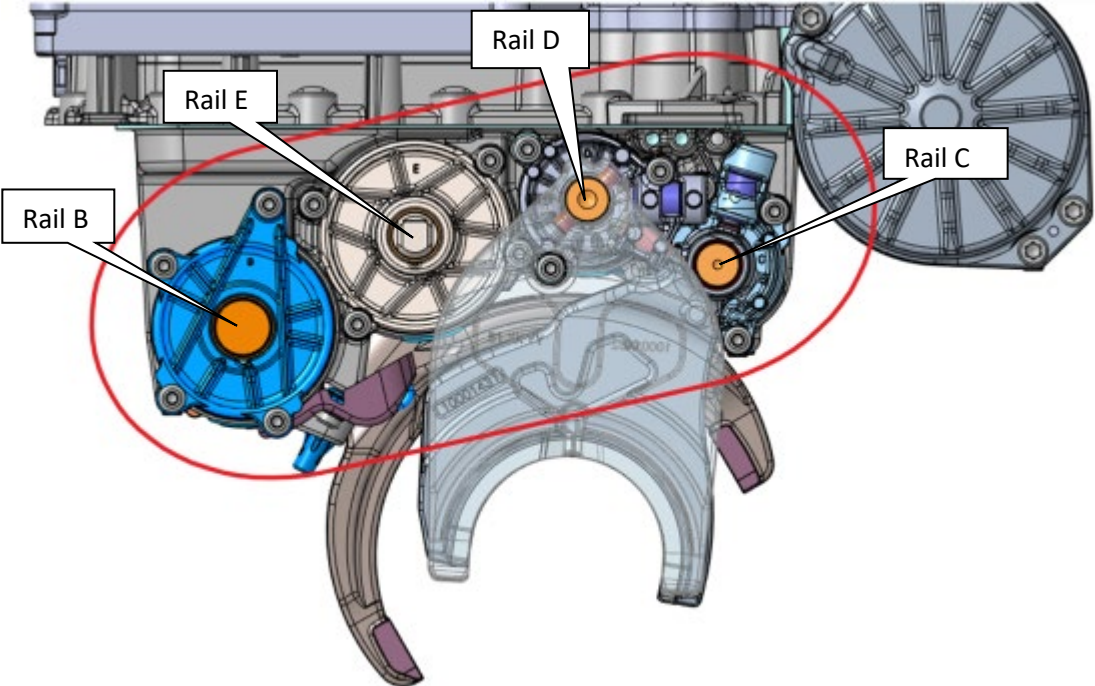
There is one cap screw on Rail C that is not accessible. Do not disassemble any other components to access this cap screw. If this cap screw is visibly loose replace the MTM.

- Perform service procedure ONLY if a rail cap screw is visibly loose.
- Pictures, loose screw position, and MTM serial number must be documented in the warranty claim.
- If no loose rail cap screws are visibly verified, no further service is needed.
