Endurant Family Transmission Information Bulletin Book TRIB0900

June 2025

Service Bulletin Index1

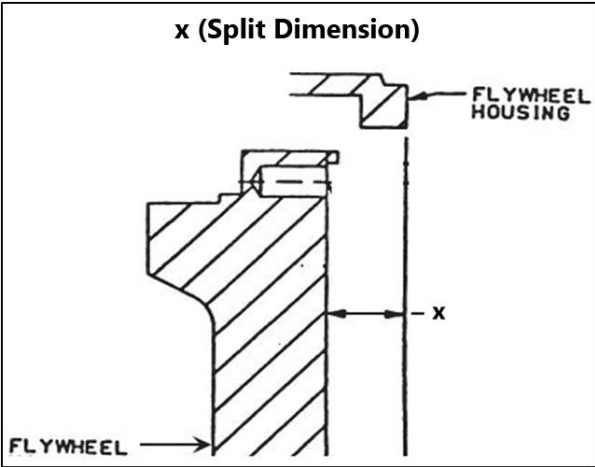
- Fault Code 250 may also be set if a flywheel was just machined.
 - a. Eaton and ECJV recommends referencing the OEM and/or engine manufacturers procedures for flywheel reuse criteria

- b. Clutch cover may not fully seat or properly attach to the flywheel. Refer to the OEM and/or engine manufacturer.

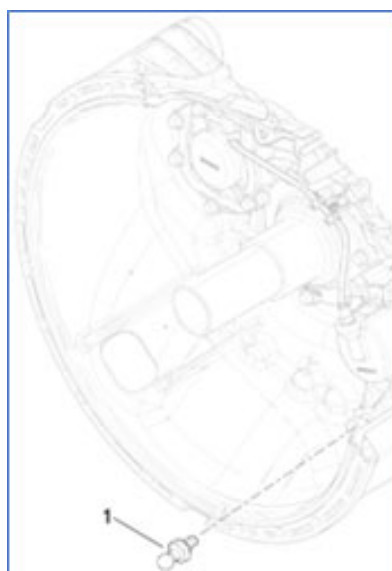
*Pivot Pin (1)*

23. Through the Clutch Housing Inspection Cover, inspect Release Yoke Pivot Pin. Do not remove transmission from vehicle.
 - If Release Yoke Pivot Pin is not broken, go to Step 24.
 - If Release Yoke Pivot Pin is broken, go to TAIB0889 HD Clutch Release System Wear/Damage.

NOTICE: Using a flashlight and pry bar, lightly pry up on the Release Yoke to determine Pivot Pin condition. Do not pry Release Yoke from Pivot Pin.

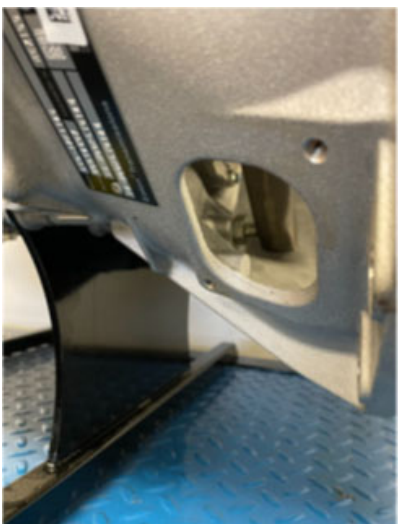
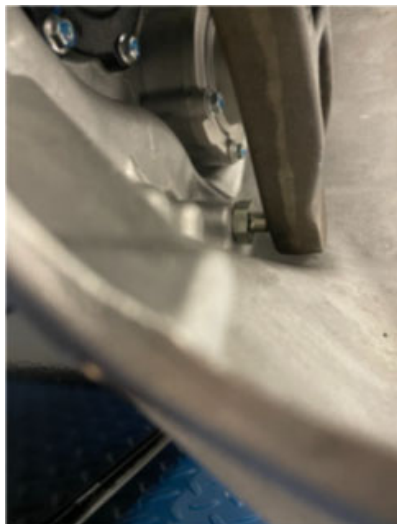
Another example of a Clutch Housing Inspection Cover removed with a new (not broken) Release Yoke Pivot Pin:

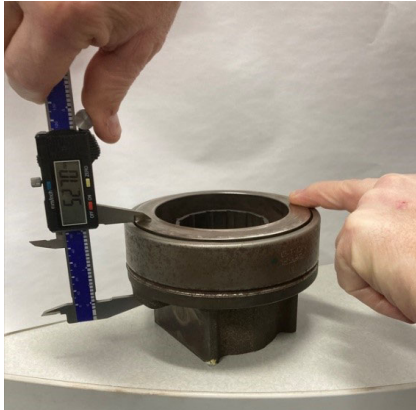
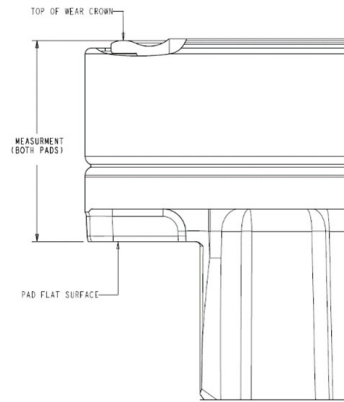
Measuring an ISO Bearing

- ISO Bearing (P/N 125969, A-10004340) Minimum Specification is 51.80 mm.
- SAE Bearing (P/N 125968, A-10004341) Minimum Specification is 44.95 mm.
- If bearing is under specification, replace release bearing assembly. Go to Step 6.
- If bearing is within specification, go to Step 5.

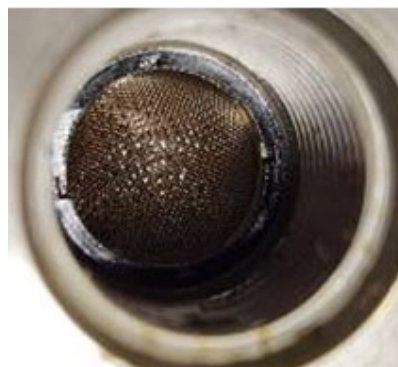
Carbon Particles

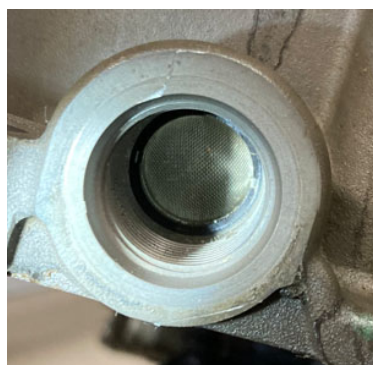
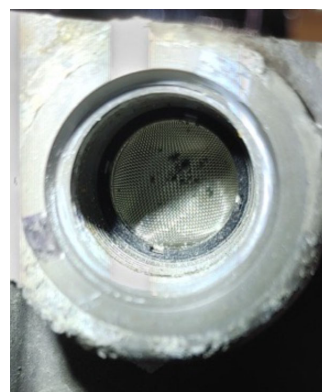
No contamination Indicated:

45 months in service

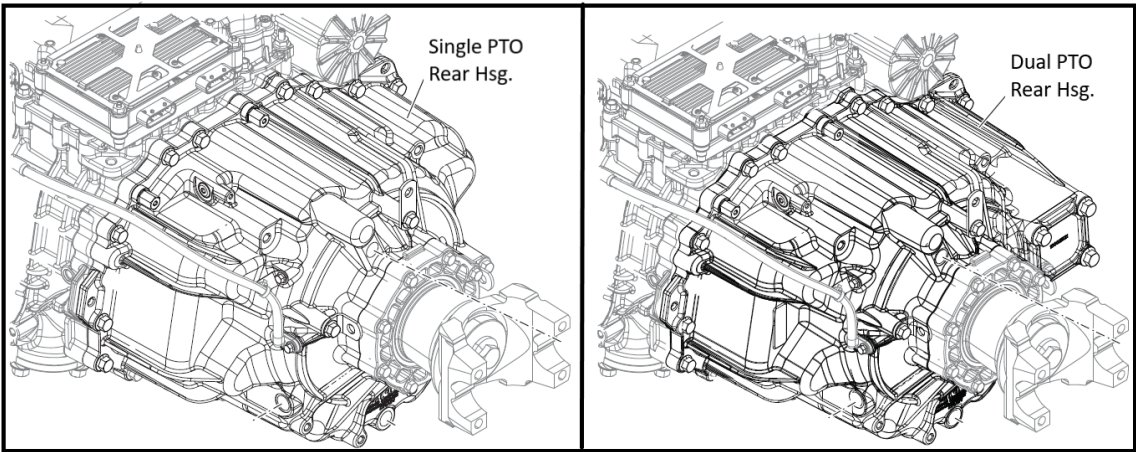
Single PTO and Dual (4-Bolt) PTO Rear Housing identification:

Some Single PTO transmission service units are built with Dual (4-Bolt) PTO Rear Housings. These units are based on a Single PTO model and do not include the internal components to support 4-Bolt PTO operation. If a 4-Bolt PTO is installed, PTO and/or transmission component damage will occur.

CAUTION: Do not install a 4-Bolt PTO on to a TN-H04-75RR or TN-H04-12R Single PTO transmission service unit equipped with a Dual (4-Bolt) Rear Housing. These service units do not include the internal components to support 4-Bolt PTO operation. If a 4-Bolt PTO is installed, PTO and/or transmission component damage will occur.

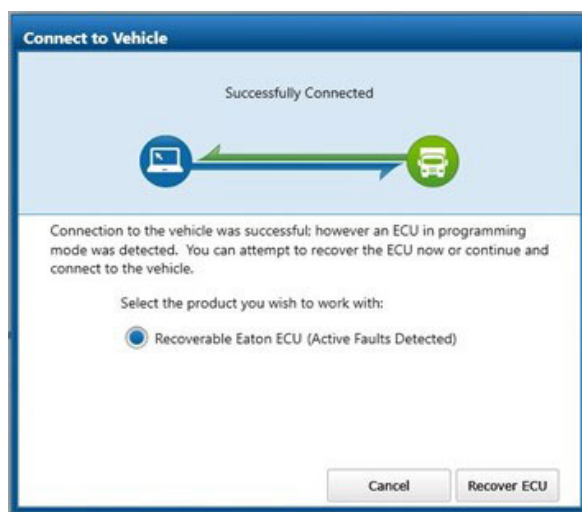
This procedure is designed to recover a Transmission Control Module (TCM) that became inoperative due to an interruption during a software update. When ServiceRanger is connected the following prompt is displayed:

In most cases, an inoperable TCM is caused by an interruption during a software update. The following conditions are required to ensure an uninterrupted successful TCM software update:

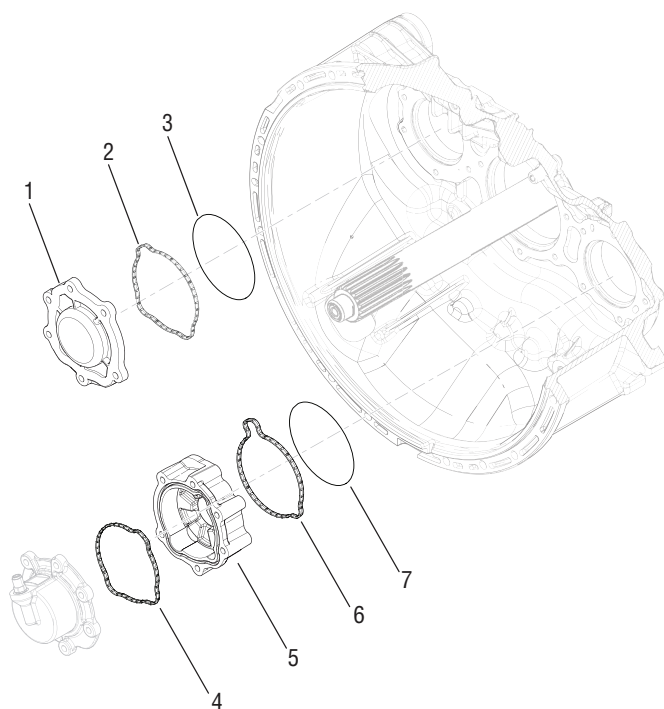
- Before correction actions:
 - Transmission start of production thru Serial Number Z0076112
- ICA 1
 - Serial Number Z0076113 thru Z0182048
 - O-rings added to aft side of countershaft bearings (Clutch Housing and Main Housing).
- ICA 2*
 - Serial Number Z0182049 thru Z0279833
 - O-rings added to fore side of countershaft bearings.
 - Upper Countershaft cover change (Item 1 changed to accept Item 3 additional O-ring) and Inertia Brake Housing change (Item 5 changed to accept Item 7 additional O-ring).
- PCA**
 - Serial Number Z0278934 and beyond
 - Added Hard Lock Design to Clutch Housing, Countershaft and Input Shaft bearings and covers, and Oil Pump.

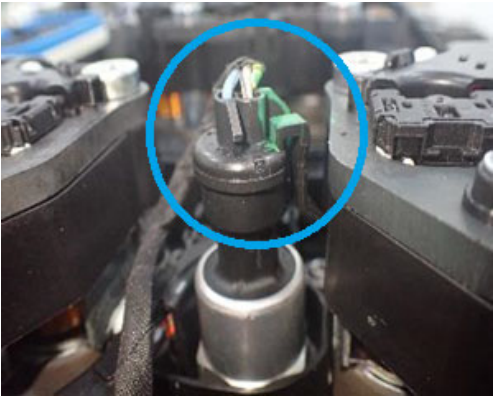
5. Inspect 3-Way TASPS Connector, confirm connector is properly seated and latched.
 - a. If connector is properly seated and latched, go to Step 6.
 - b. If connector is not properly seated or latched, record findings and go to Step 6.

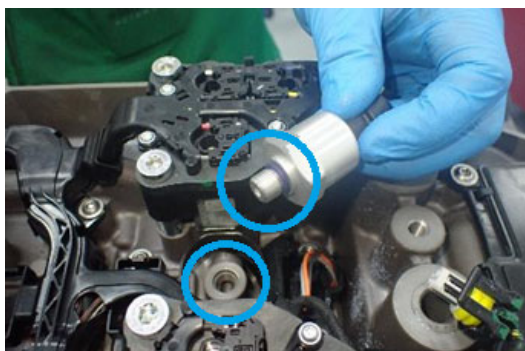
9. Inspect removed TASPS and MTM side of TASPS threaded opening, ensure O-ring came out with sensor and opening is free of debris.

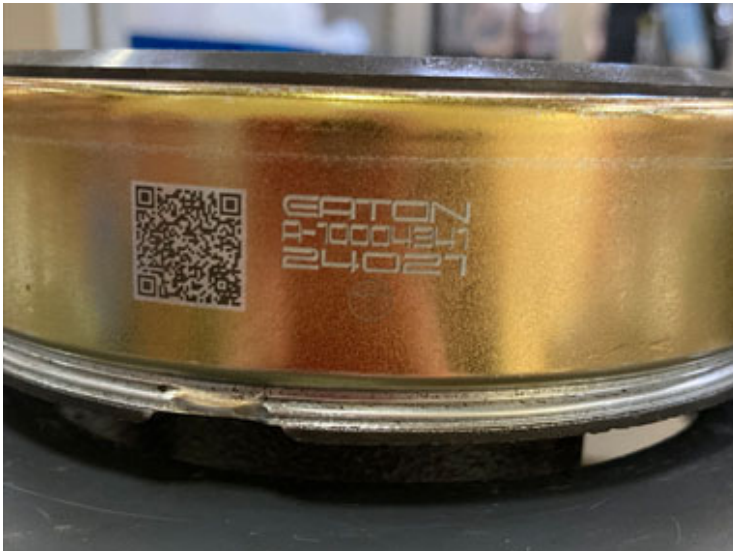
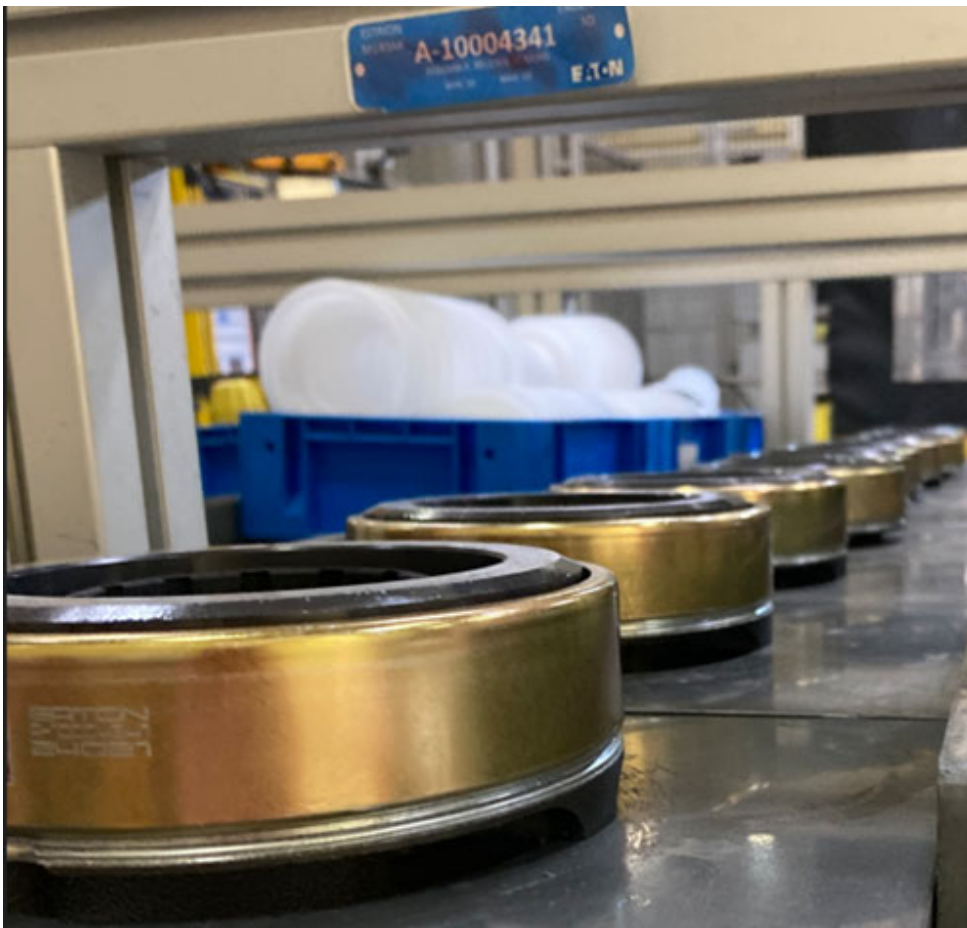
June 4, Eaton Production Line:

All A-10004341 SAE release bearings have the proper gold zinc color.

1,960 A-10004341 SAE Release Bearings were produced off color June 12, 2023 through July 21, 2023 (supplier production Dates).

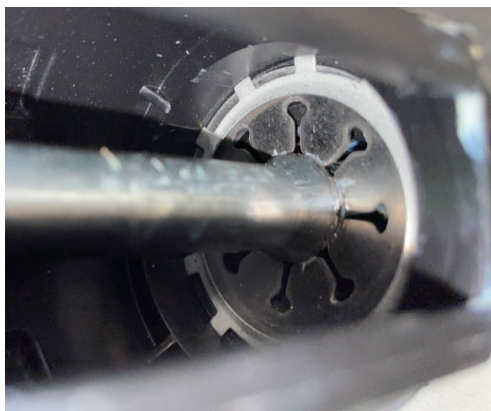
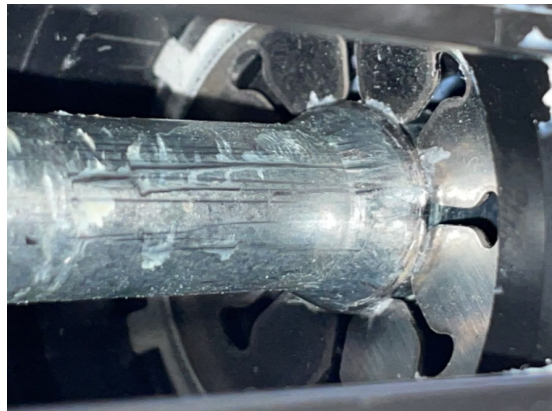
Additionally, the LCA may not have been fully locked into the reset position due to not being fully compressed during the LCA reset procedure. Picture below indicates a properly reset LCA, locking ring tabs fully locked into the push rod.

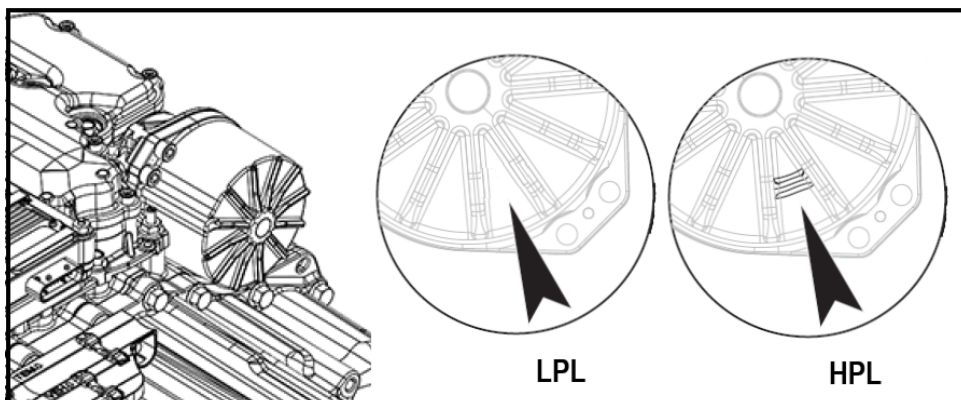
- High Pre-Load (HPL) type LCA (raised casting at 5 o'clock position) with a single locking ring retainer.

12-Speed: HPL LCA Part Number A-10004457

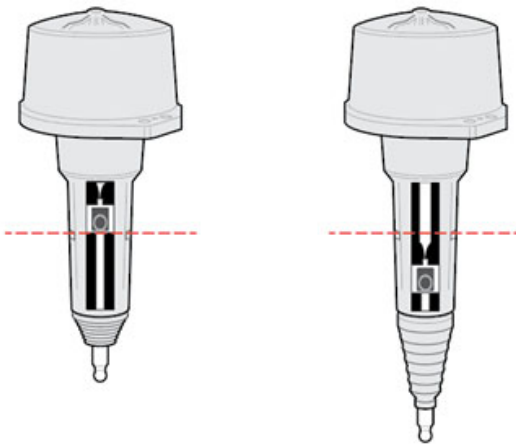
Locked in Reset Position

Not Locked in Reset Position

- If the LCA locking ring retainer is out of position, replace LCA.
- If the LCA locking ring retainer is in place, go to Step 2.
