Subject: MTM Solenoid Fault Codes and Vehicle Air System Contamination – Endurant HD, XD and PACCAR TX-12, TX-18

Document Number: TAIB-1006

Date: April 6, 2023

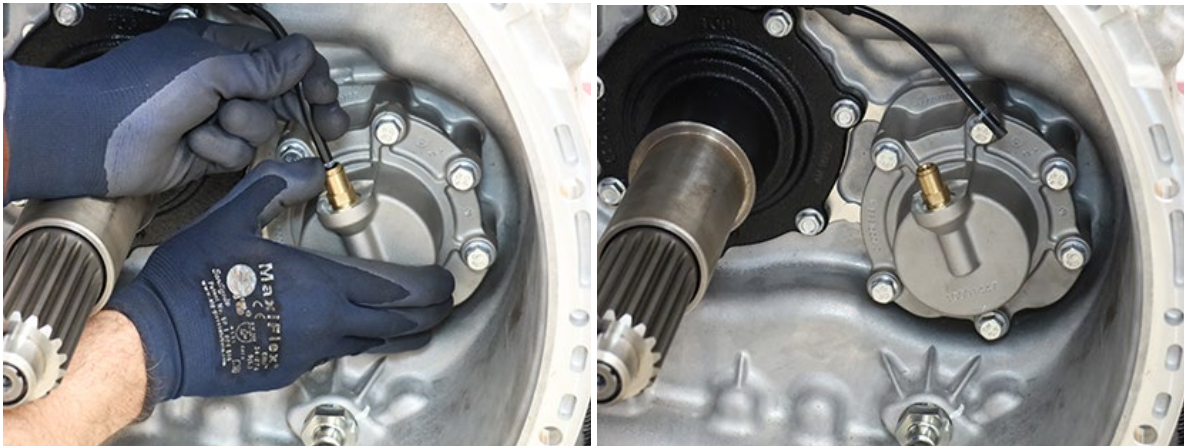
14. Inspect Inertia Brake Air Line and fitting for Black and Amber substance.
 - If Black or Amber substance present, recording findings in warranty claim, and replace: MTM, Inertia Brake Assembly and Inertia Brake Air Line (Warrantable Repair).
Note: Reinstall MTM Cover per **Steps 15, 16** and **17**.
 - If **no** Black or **no** Amber substance is present, **reconnect** Inertia Brake Air Line and record findings in warranty claim. Go to **Step 15**.
Note: Ensure air line is fully seated into fitting.

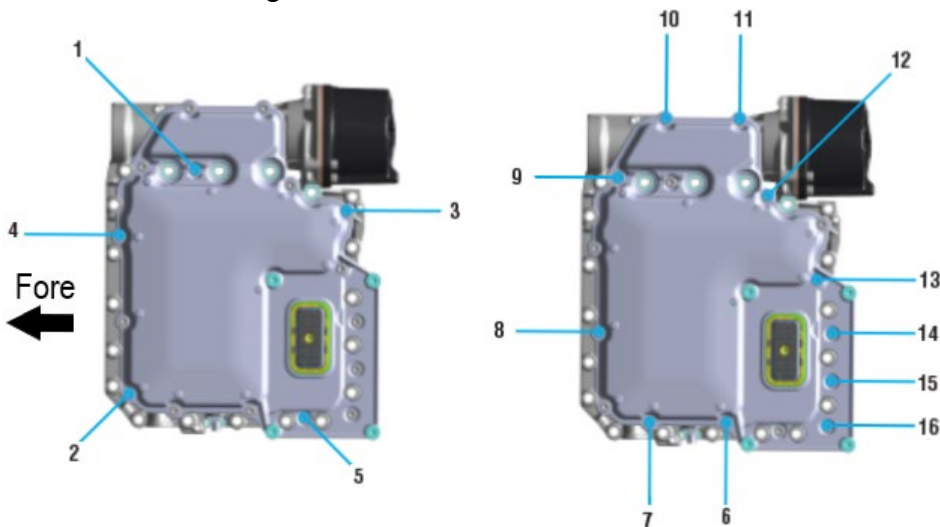
CAUTION: Follow the MTM Cover cap screw torque specification and sequence as shown. Failure to follow torque specification and sequence may damage MTM Housing, Cover and O-ring.

17. Torque MTM Cover cap screws 1 through 5 and 6 through 16 to 23–27 Nm (17-19 ft-lb) as shown in the torque sequence below.
