Warranty Repair Guidelines TCWY1250 EN-US

May 2020

Mechanical Transmission

(Pre-Authorization Warranty Repairs)

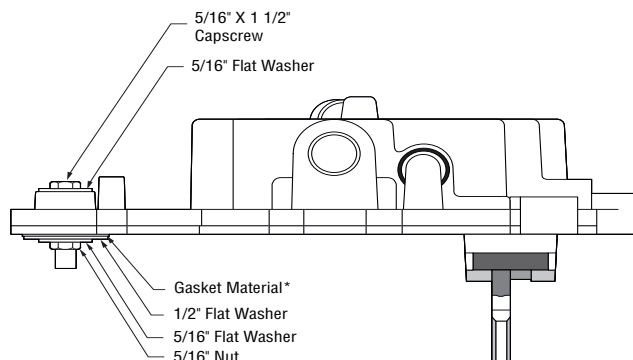
Air Module Isolation

* Gasket material must be used to seal the two holes in the bottom of air module.

With module still mounted, install a 0-100 psi test gauge in each high (H) and low (L) test port on top of the module. Supply a minimum of 90 psi to the module inlet port and operate the range lever between high and low range. Slow response in either direction or a pressure reading outside the 75-85 psi range equals a failed module.

If troubleshooting steps indicate the module is defective or the regulated pressure is out of range (75-85 psi), replace the module as a unit. The module is not a serviceable unit.

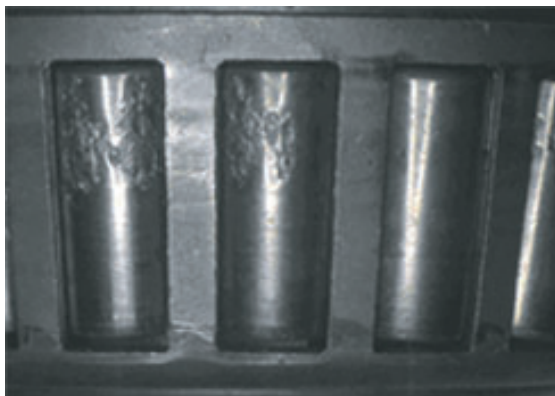
Replace

When pitting/spalling exists, disassemble auxiliary to replace auxiliary countershaft bearings and inspect remaining components.

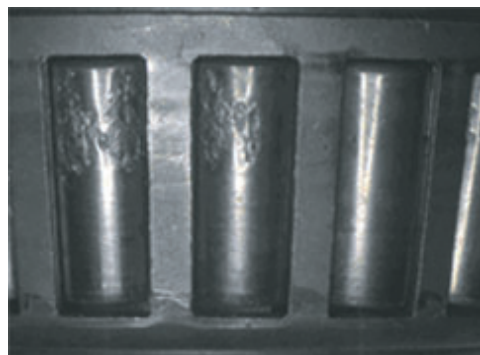
Replace

When pitting/spalling exists, disassemble auxiliary to replace auxiliary countershaft bearings and inspect remaining components.

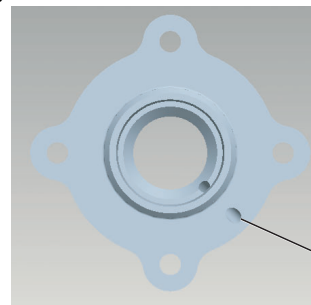
Feed air manually to this port, listen for piston to move in and out.

After T/S of fault code if the technician determines the need to disassemble, try shop air to the cylinder housing port manually before disassembly, listening to determine if the piston moves in and out. Once the need to visually inspect the splitter cylinder is determined the tech may replace the o-rings and re-lube the cylinder walls with the silicone lubricant provided in the kit.

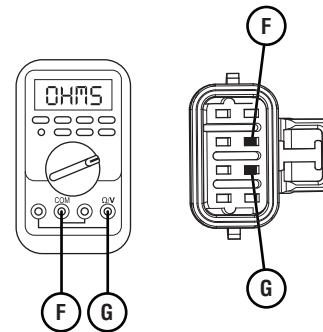
4. Measure resistance between 8-Way Connector Pin F and Pin G. Record reading(s) in table based on configuration.

- If readings are out of range, and harness is undamaged, replace ECA Speed Sensor K-4149 go to **Step V.**
- If readings are in range, replace ECA with updated K-4252. go to **Step V.**

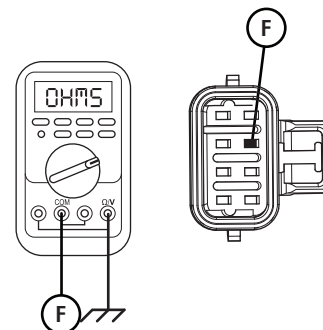
5. Measure resistance between 8-Way ECA Connector Pin F to ground. Record reading(s) in table.
