Subject: Software Download Process of SW-18187-P (5516009 or 5516010) – Endurant and PACCAR Transmissions

Document Number: TAIB-0877

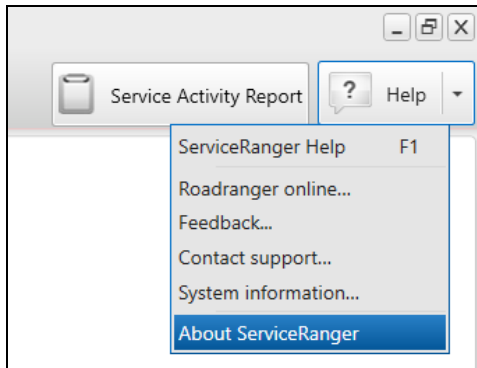
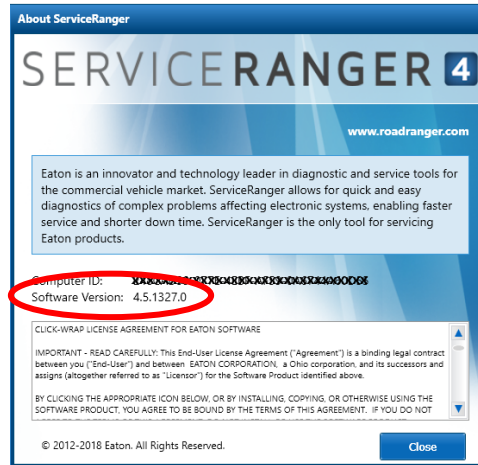
To verify software version open ServiceRanger > select Help > select About ServiceRanger:

The 5516009 and 5516010 software are in ServiceRanger Application 4.5.1327 database update version 1807-01-C-2635 at an RFM License and above.
