Subject: Transmission ECU Recovery Procedure – UltraShift®*PLUS* and Fuller Advantage® Automated

Document Number: TAIB-0886

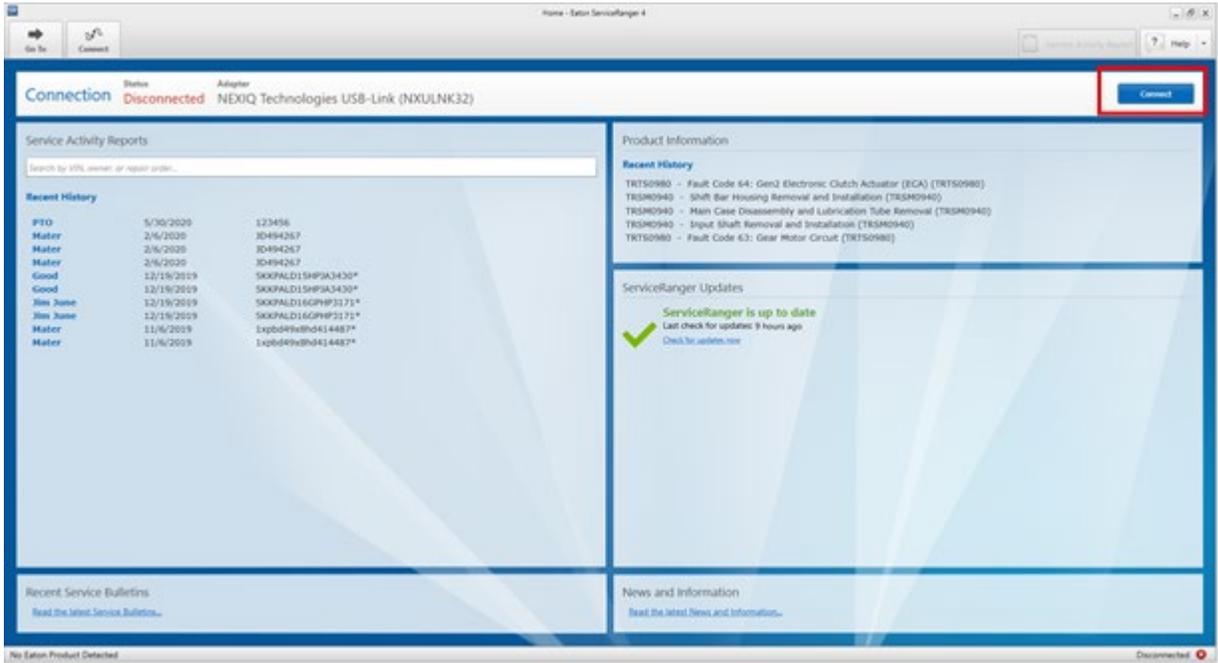
- Click on "Connect" in ServiceRanger then within 10 seconds Key- On the vehicle ignition.

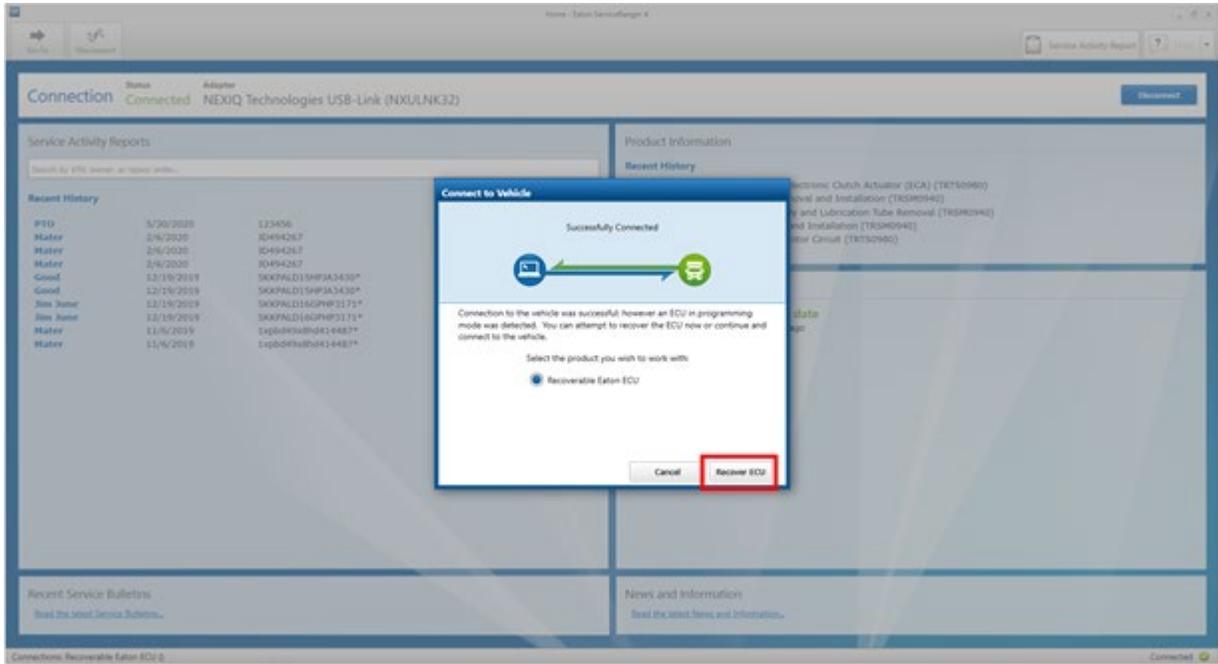
- Select "Recover ECU".

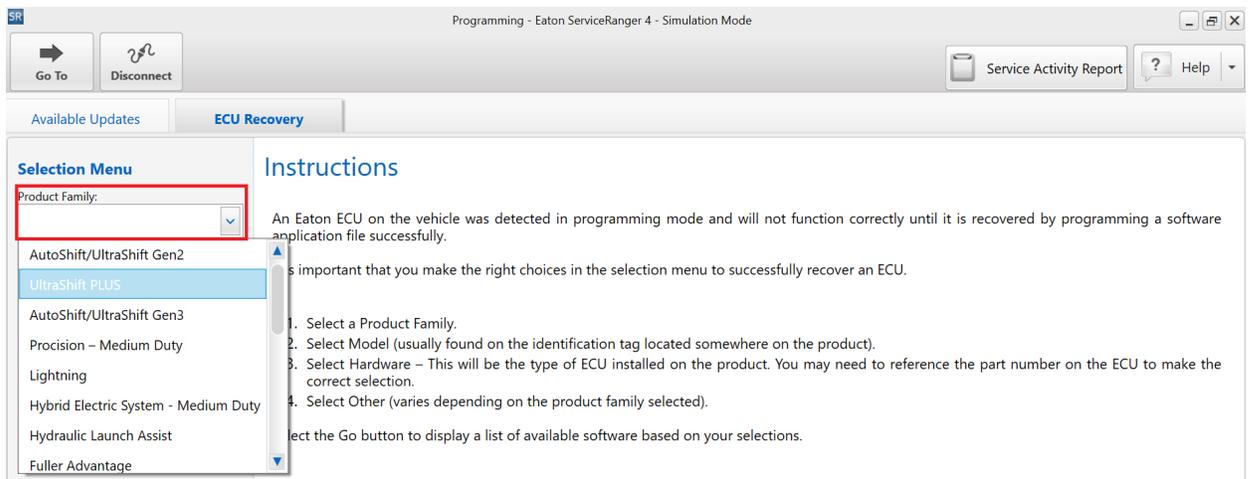
6. Once on the ECU Recovery tab, select the appropriate transmission product family, UltraShift PLUS or Fuller Advantage, from the “Product Family” dropdown.

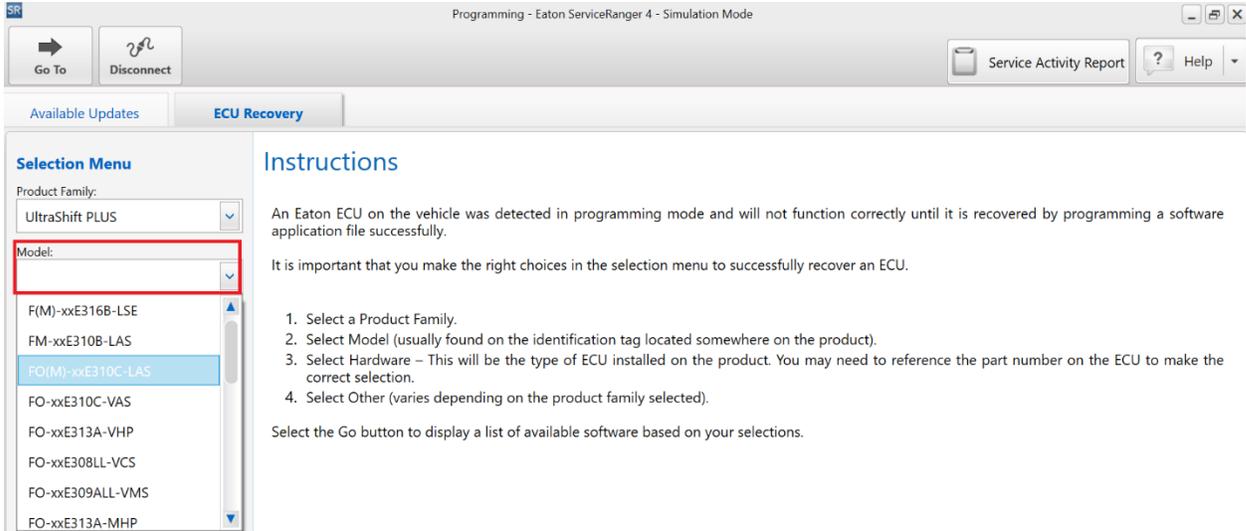
7. Select the appropriate transmission model from the “Model” dropdown.

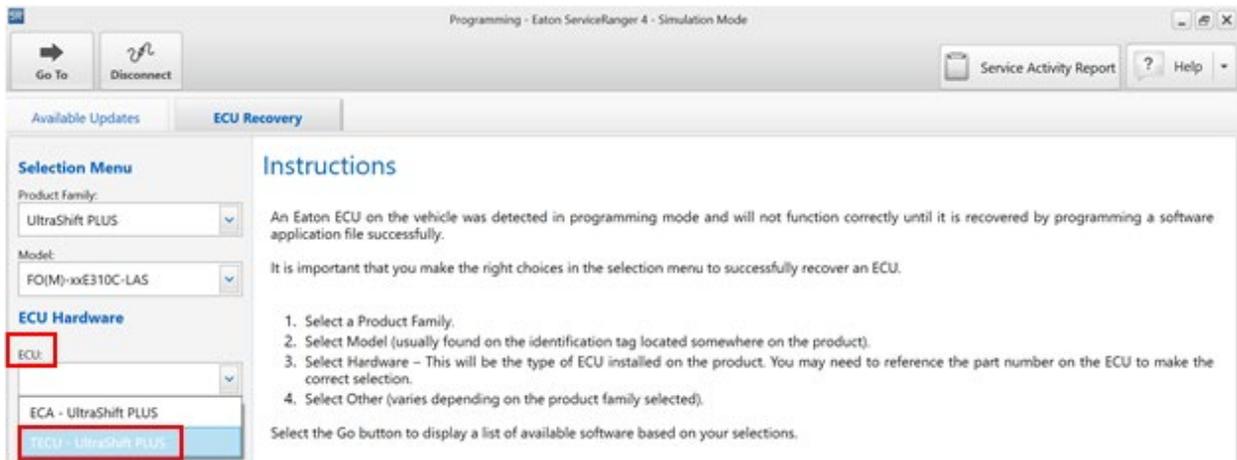
8. Select the “TECU” option from the “ECU” dropdown.

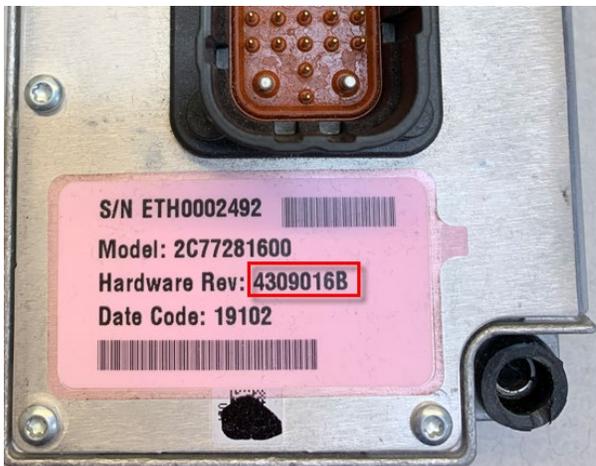
9. Go to the TECU and record the Hardware Rev. number. See example below.

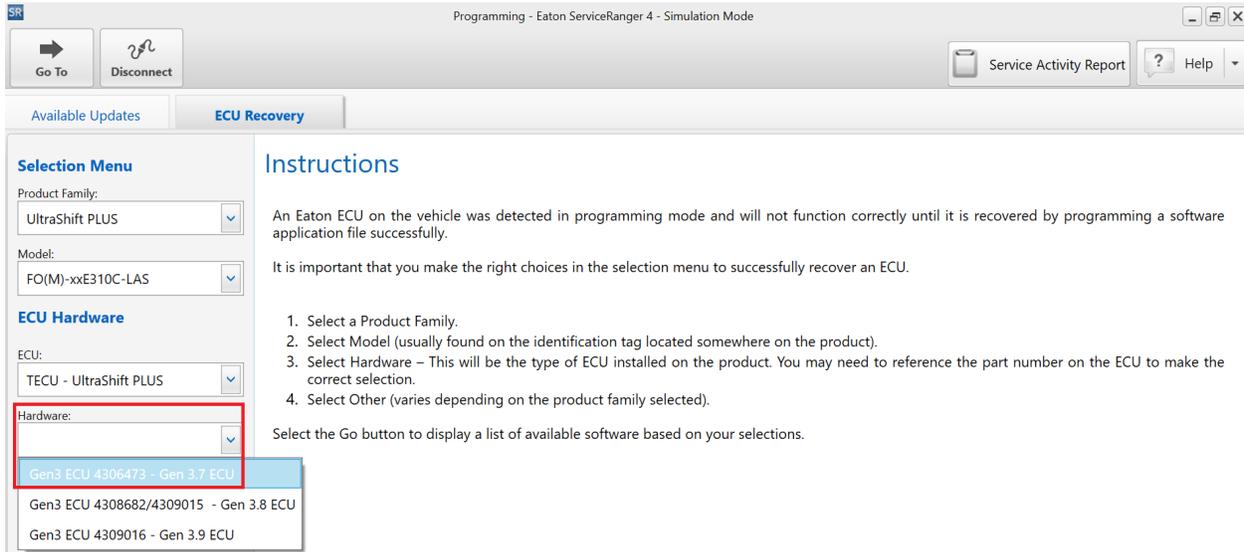
10. Based on the Hardware Rev. number recorded in Step 9, select the appropriate transmission hardware version from the “Hardware” dropdown.

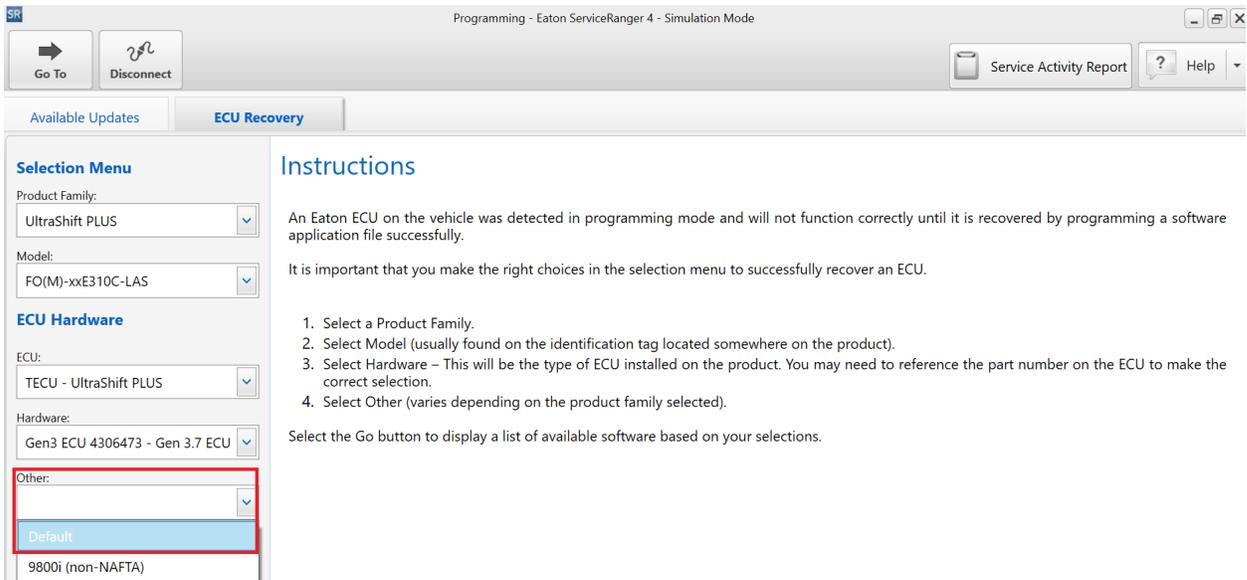
11. Select “Default” from the “Other” dropdown.

Note: If running an older version of ServiceRanger this drop down may show as “0” or “1”, Choose “0”.

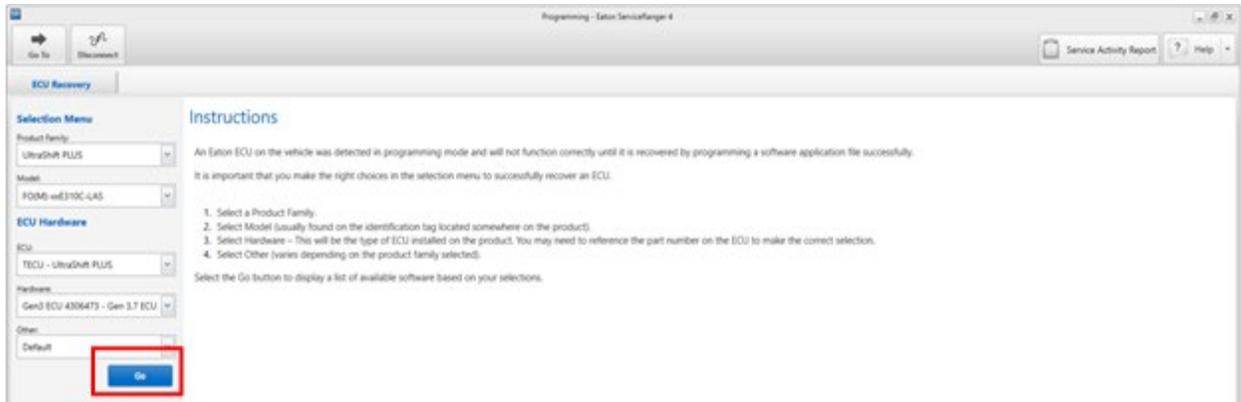
12. Select “Go”.

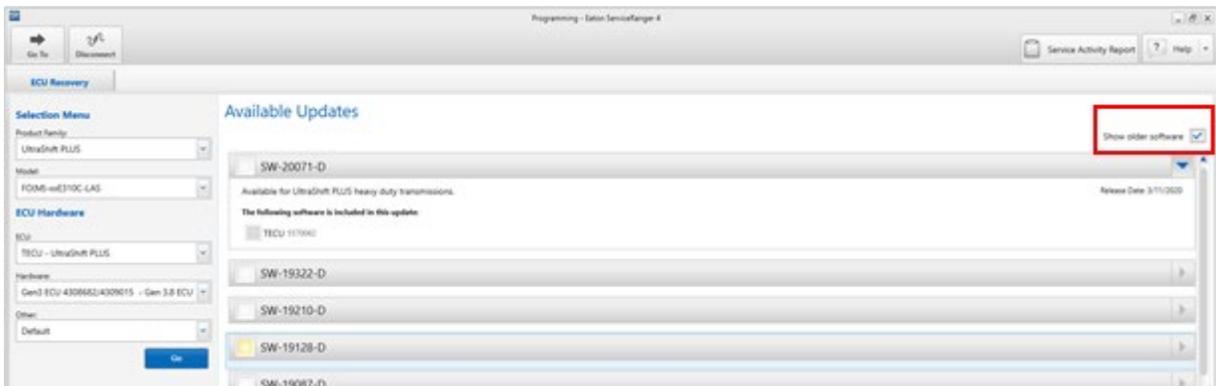
13. Select “Show older software”

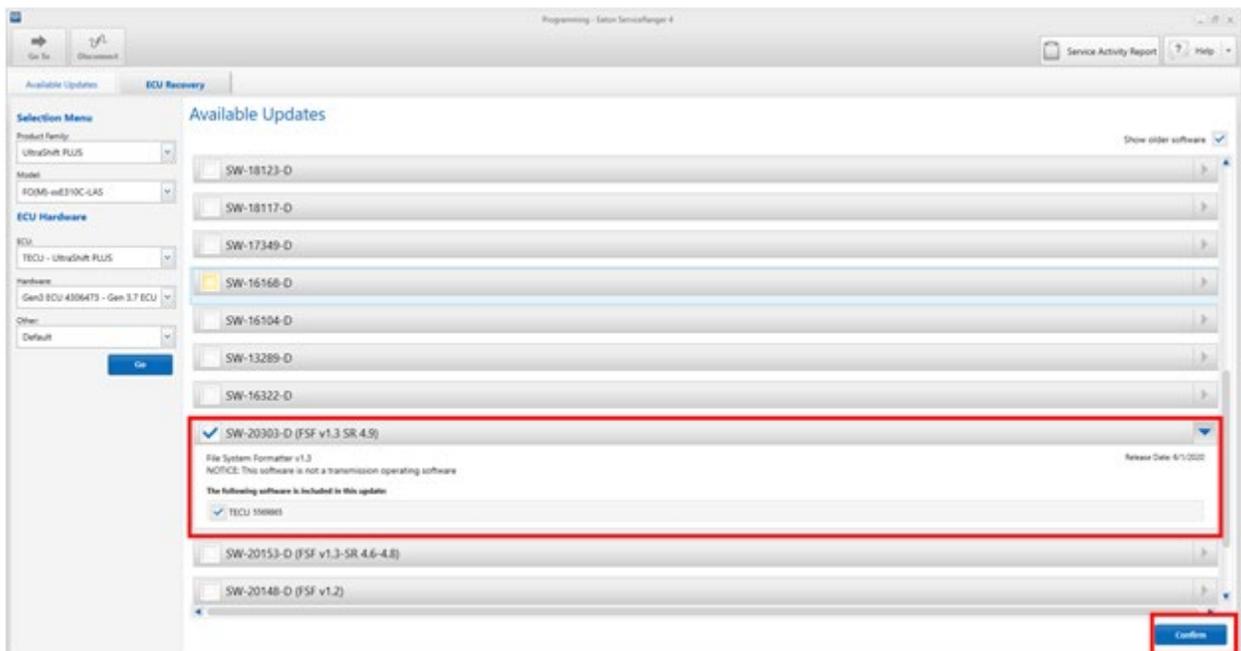
14. Select “SW-20303-D (FSF v1.3 SR 4.9)” TECU 5569865 Update and select “Confirm”.

Note: It may be necessary to scroll down the list to find the software update.

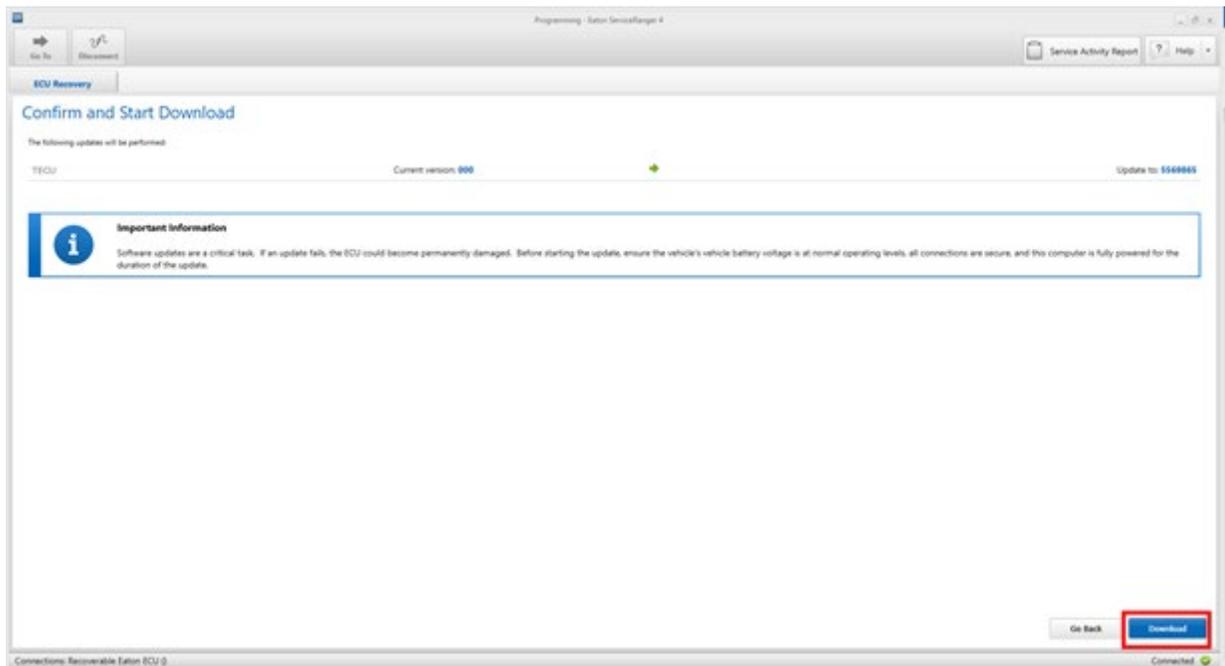
15. Select “Download”

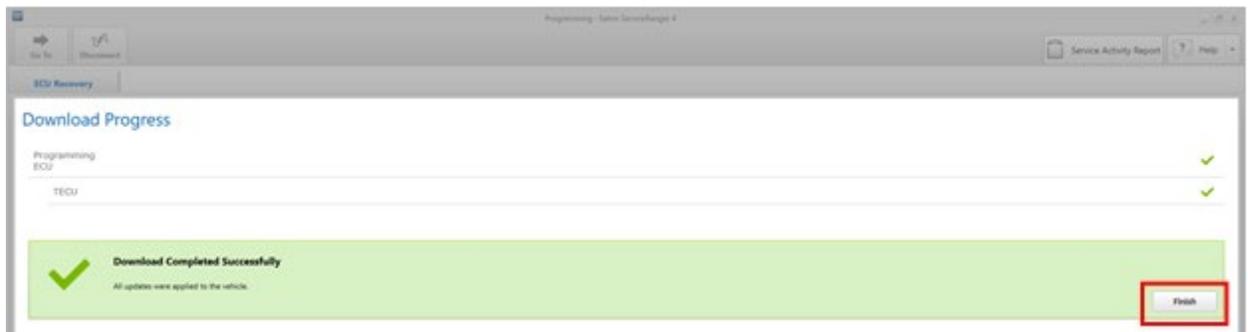
16. Once the Download is complete, Select “Finish”.

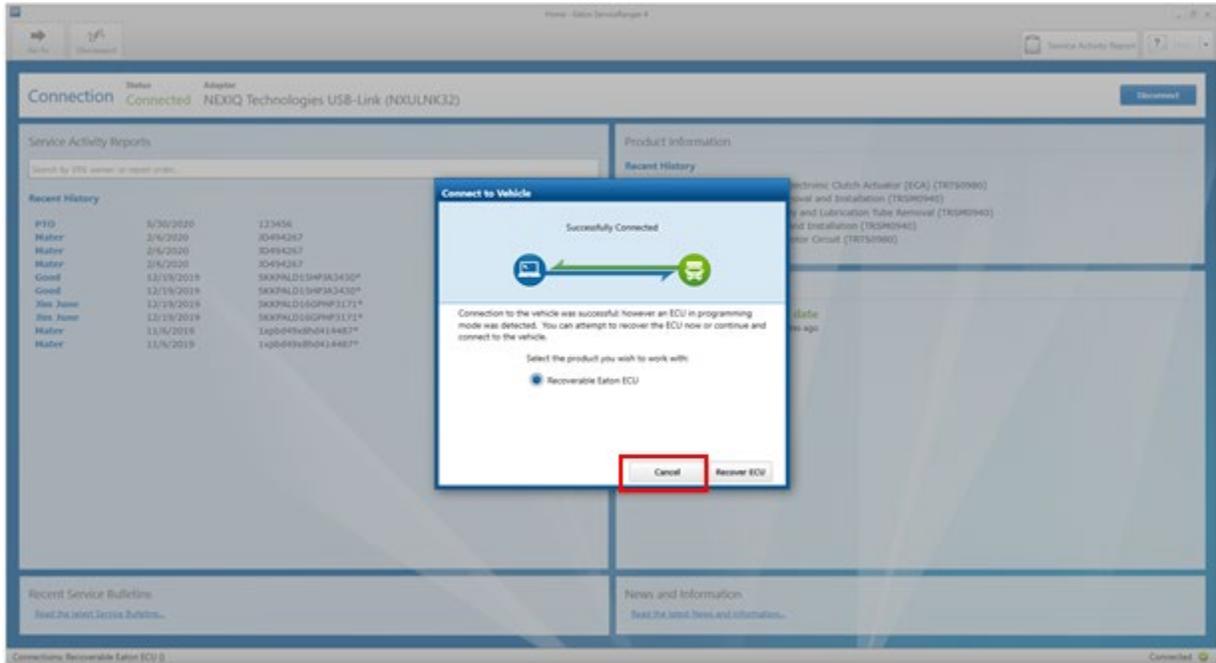
17. After selecting “Finish”, ServiceRanger will ask you to recover the TECU, select “Cancel”.

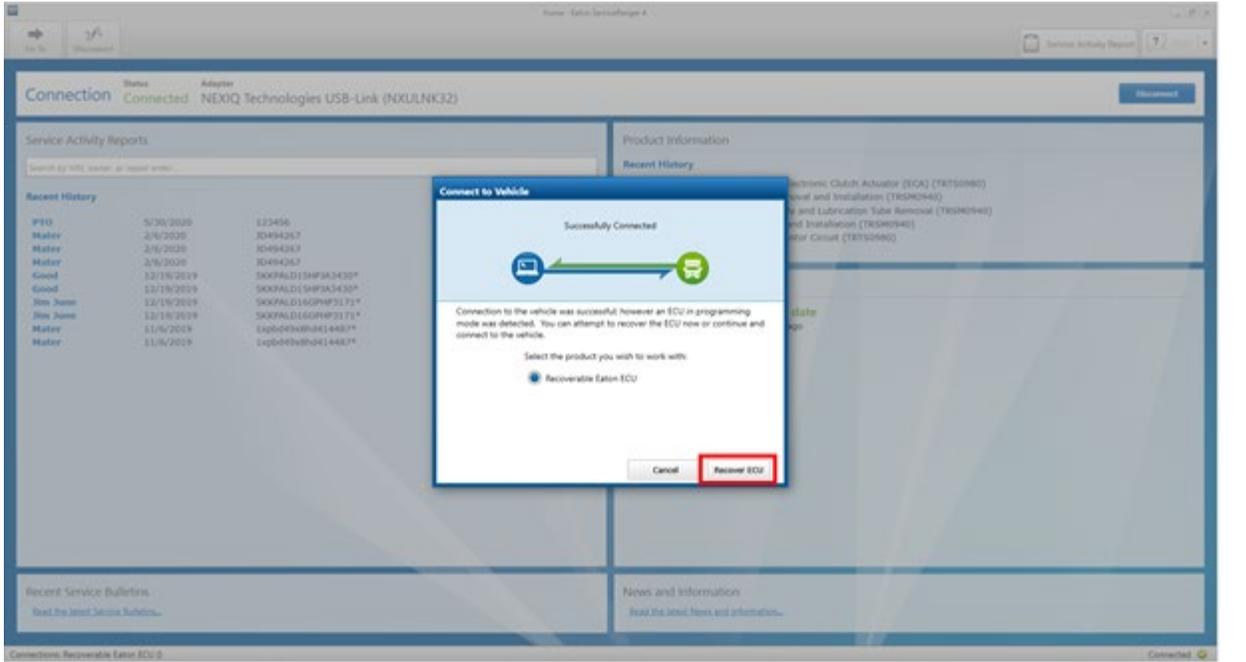
22. Select “Recover ECU”.

The screenshot shows the Eaton ServiceRanger 4 software interface. A 'Connect to Vehicle' dialog box is open, displaying a 'Successfully Connected' message. Below the message, it states: 'Connection to the vehicle was successful, however an ECU in programming mode was detected. You can attempt to recover the ECU now or continue and connect to the vehicle.' Underneath, it asks to 'Select the product you wish to work with' and shows a radio button selected for 'Recoverable Eaton ECU'. The 'Recover ECU' button is highlighted with a red box.

Below the dialog box, the main interface shows the 'SR' (ServiceRanger) window. The title bar reads 'Programming - Eaton ServiceRanger 4 - Simulation Mode'. The 'Available Updates' section has a red box around the 'ECU Recovery' update. The 'Selection Menu' section has two dropdown menus for 'Product Family' and 'Model', and a 'Go' button. The 'ECU Hardware' section is also visible.

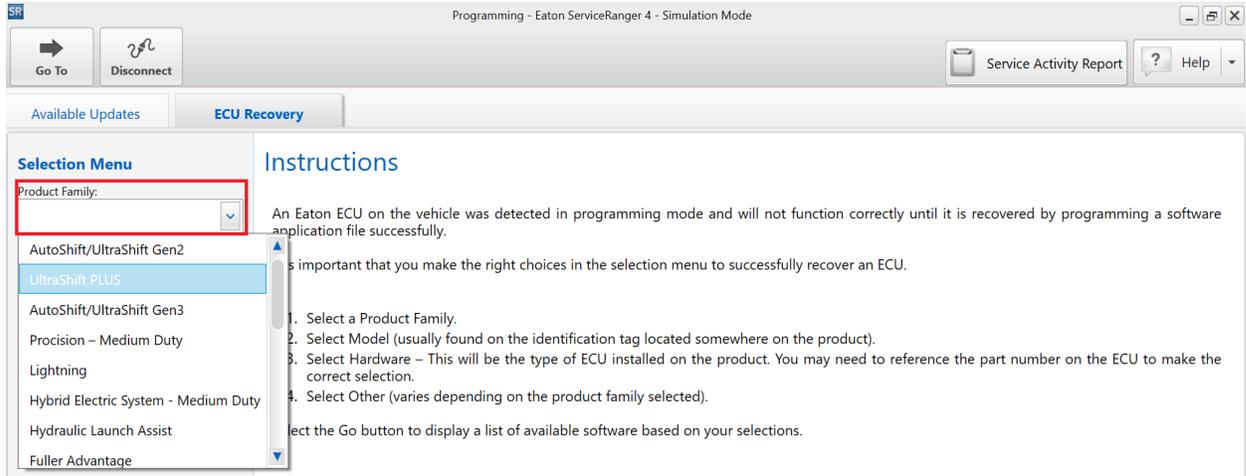
23. Select the appropriate transmission product family, UltraShift PLUS or Fuller Advantage, from the “Product Family” dropdown.

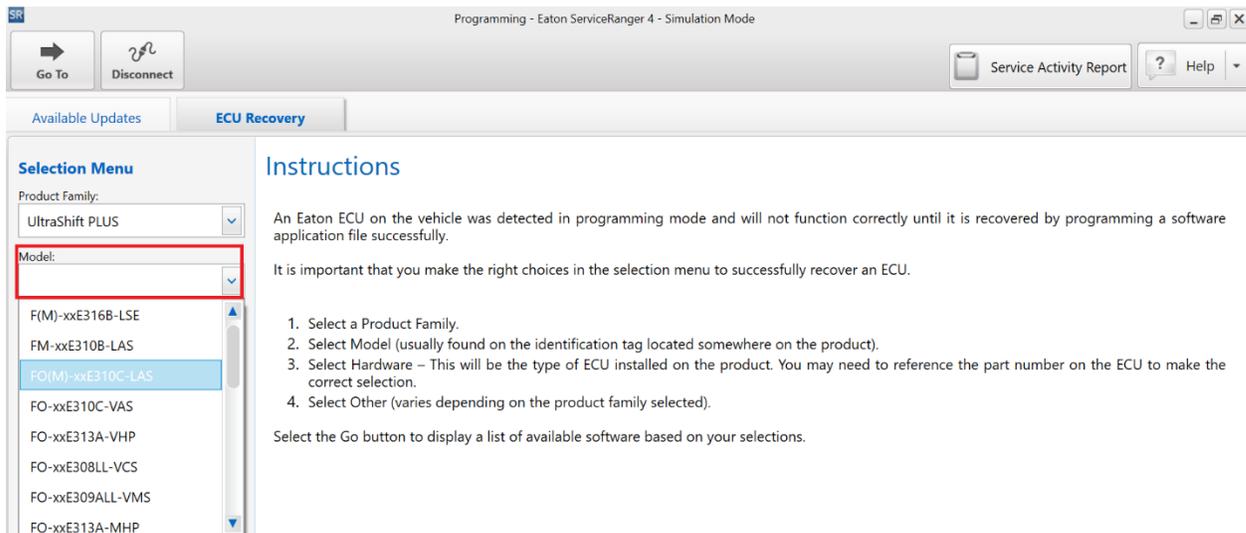
24. Select the appropriate transmission model from the “Model” dropdown.

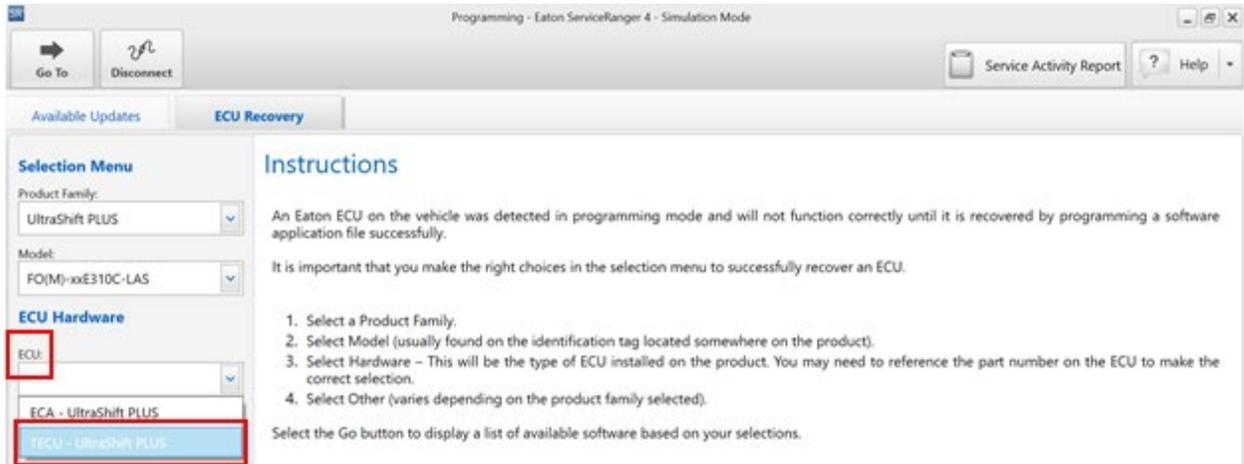
25. Select the “TECU” option from the “ECU” dropdown.

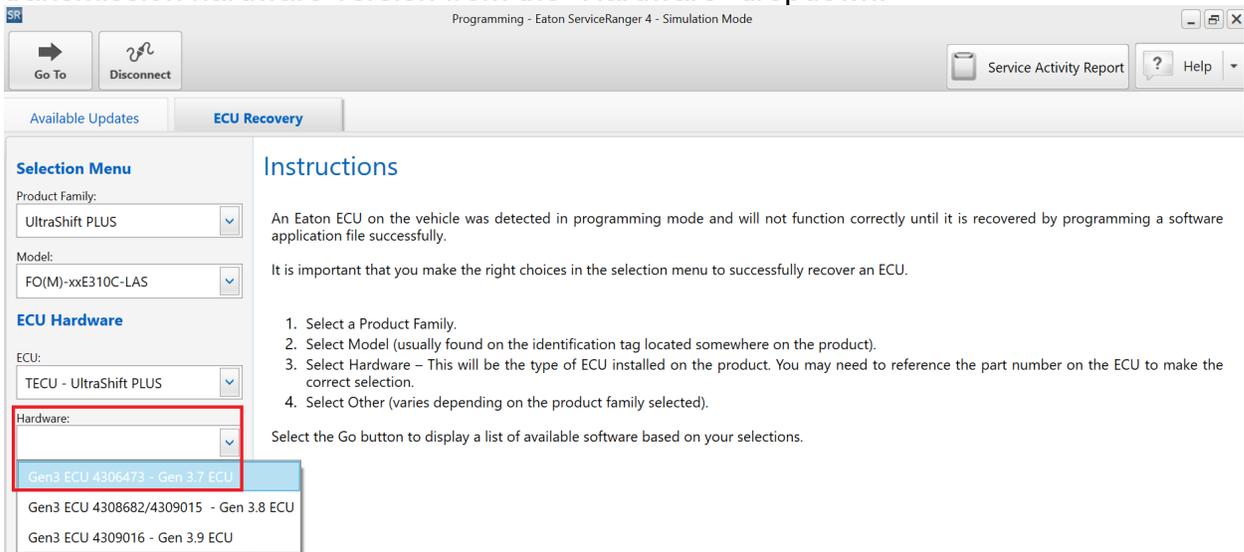
26. Based on the Hardware Rev. number recorded in Step 9, select the appropriate transmission hardware version from the “Hardware” dropdown.

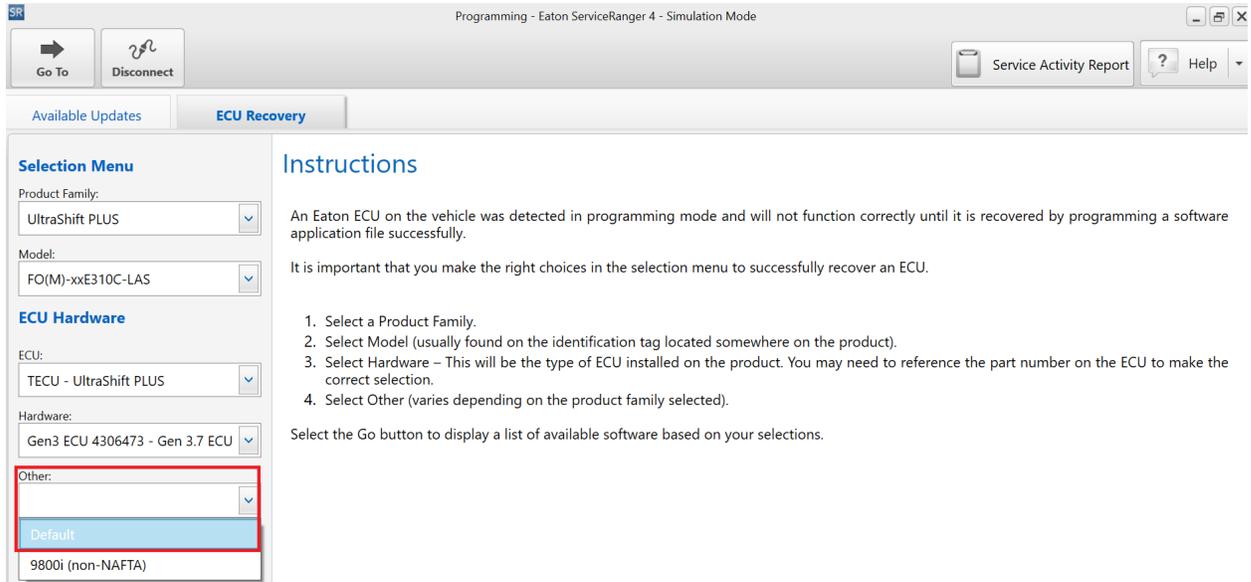
27. Select “Default” from the “Other” dropdown.

Note: If running an older version of ServiceRanger this drop down may show as “0” or “1”, Choose “0”.

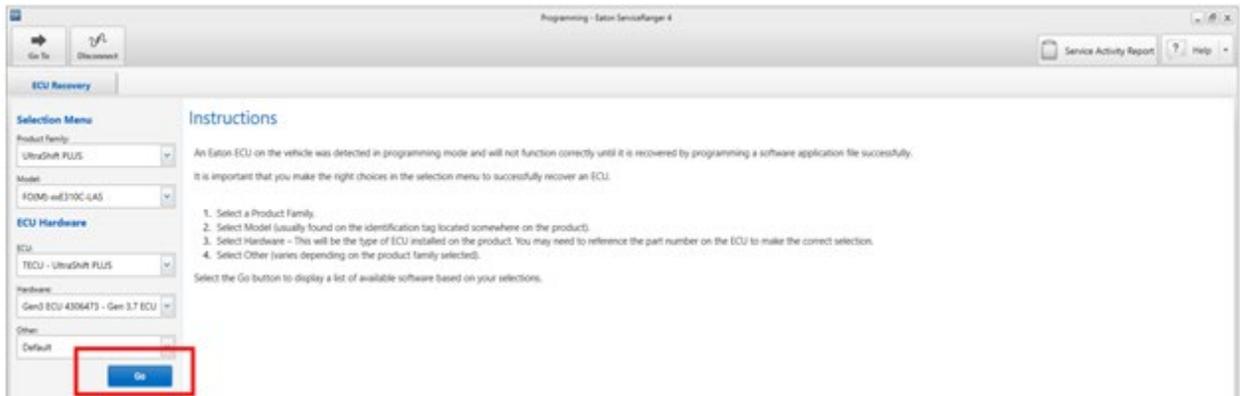
28. Select “Go”.

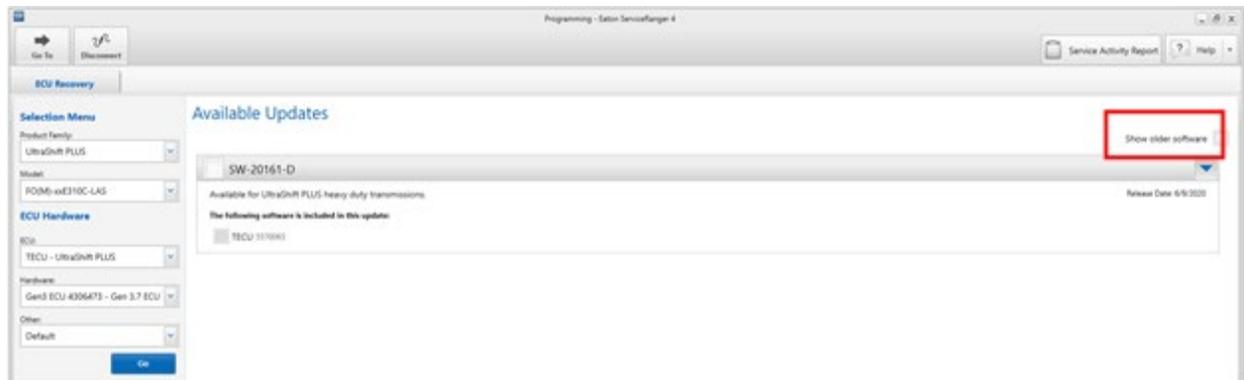
29. Unselect “Show older software” and following the on-screen prompts, program the TECU to the latest available software.
